Mountain View Fire Cost Recovery Application

Before the California Public Utilities Commission

Liberty-02: Ignition

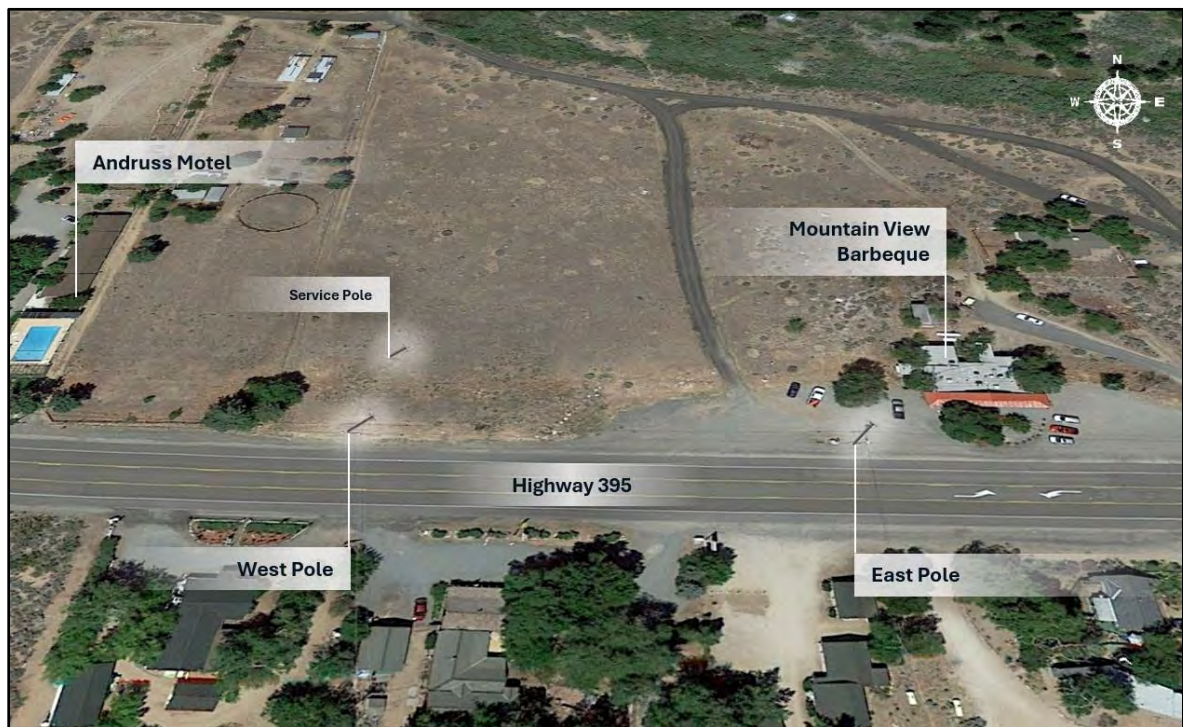
Figure 1: Origin Area of the Mountain View Fire

The Mountain View Fire ignited shortly before noon on November 17, 2020, near the town of Walker in Mono County, California. A 911 caller first reported the fire at approximately 11:58 a.m., and the fire was first observed in a grassy field adjacent to an area of Highway 395 that runs east and west. Cal Fire investigated the origin and cause of the Mountain View Fire and issued a report. Based on fire spread indicators, evidence collected, and witness statements, the report concludes that the “most probable” cause of the fire was an energized conductor contacting the ground and igniting grassy fuels between the East and West Poles.³ The origin area of the fire is shown in Figure 1.

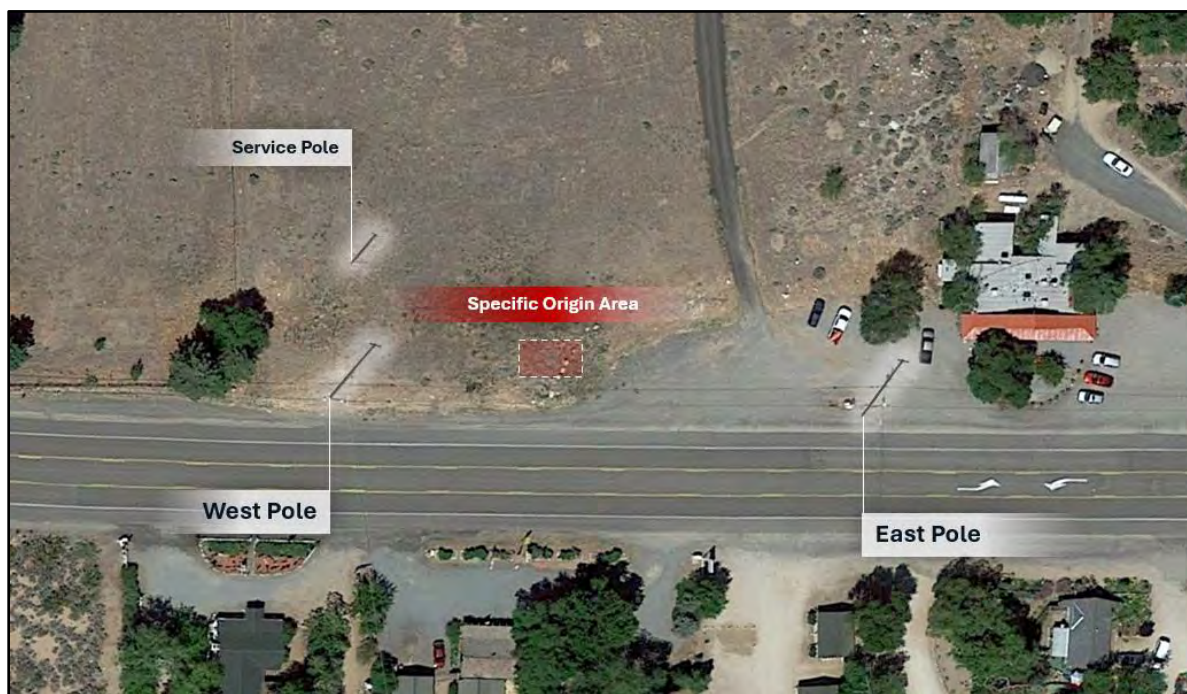
Figure 2: Specific Origin Area Identified by Fire Agency Report, with the West and East Poles Marked

Properly identifying a specific origin area is a critical step in the wildland fire investigative process. It is only after identifying a specific origin area that investigators should seek to identify the cause of the ignition within that specific origin area. Here, the investigators did not conduct a broad enough search to accurately identify a specific origin area. The only area the investigators appear to have examined thoroughly was the area of the field where a section of damaged conductor was found

lying on the ground adjacent to bleached rocks.⁵ The fire agency report indicates that investigators mistakenly identified and focused on stains they thought were burn marks on rocks near this area and indications of ignition, and failed to search for and consider further evidence. Smoke patterns on these rocks, however, would have been indistinguishable between any arc flash and consumption of nearby fuel by the fire, and were adjacent to vegetation that was consumed by the fire some time after its ignition. Based on this, the fire agency report identified a specific origin area—a six feet by twelve feet rectangular area near the end of the conductor and the burned rocks. This area is located between the West and East Poles, just west of a parking turnout, as shown in Figure 2.⁶ This location, however, appears unburned by an approaching flanking fire in photographic and video evidence captured by eyewitnesses shortly after the fire began (Figure 3), further indicating that fire agency investigators did not correctly identify the specific origin area of the fire.

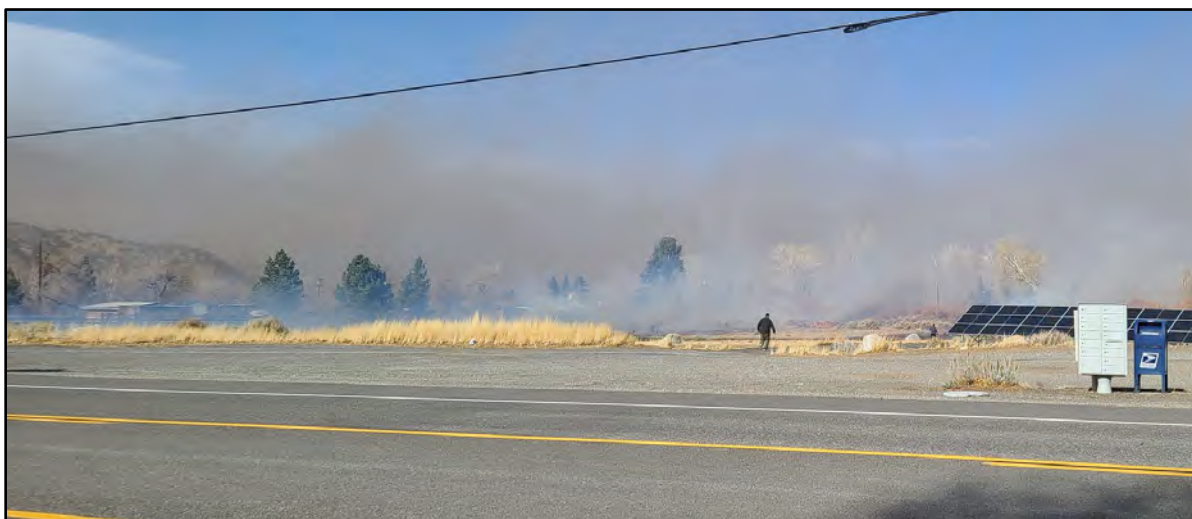
Figure 3: 12:01 p.m. Photograph of Specific Origin Area After Ignition

The fire agency investigation was complicated by environmental conditions, which impacted the evidence available to fire agency investigators and, as a result, limited their ability to draw reliable conclusions regarding the fire’s origin and cause. High winds and rain in the area of origin following ignition of the fire limited the quantity and availability of fire movement indicators that fire agency investigators could analyze (though the rainfall aided fire suppression efforts, as described in *Liberty-04: External Factors*).⁷ This rainfall occurred before fire agency investigators arrived on scene the day following the ignition, and may have limited their ability to draw reliable conclusions from the remaining markers. In standard wildland fire investigations, investigators meticulously identify, document, and analyze a large number of fire movement indicators in and around the suspected general area of origin to understand the fire’s movement and progression, as well as to identify the specific area where it originated. In contrast, the number of fire movement indicators that fire agency investigators documented and analyzed for the Mountain View Fire was quite small, which limited their ability to draw reliable conclusions regarding the fire’s specific origin area. It is also notable that one of the investigators assisting the fire agency investigation identified ignition points that appear to be outside the specific origin area identified by the fire agency report.

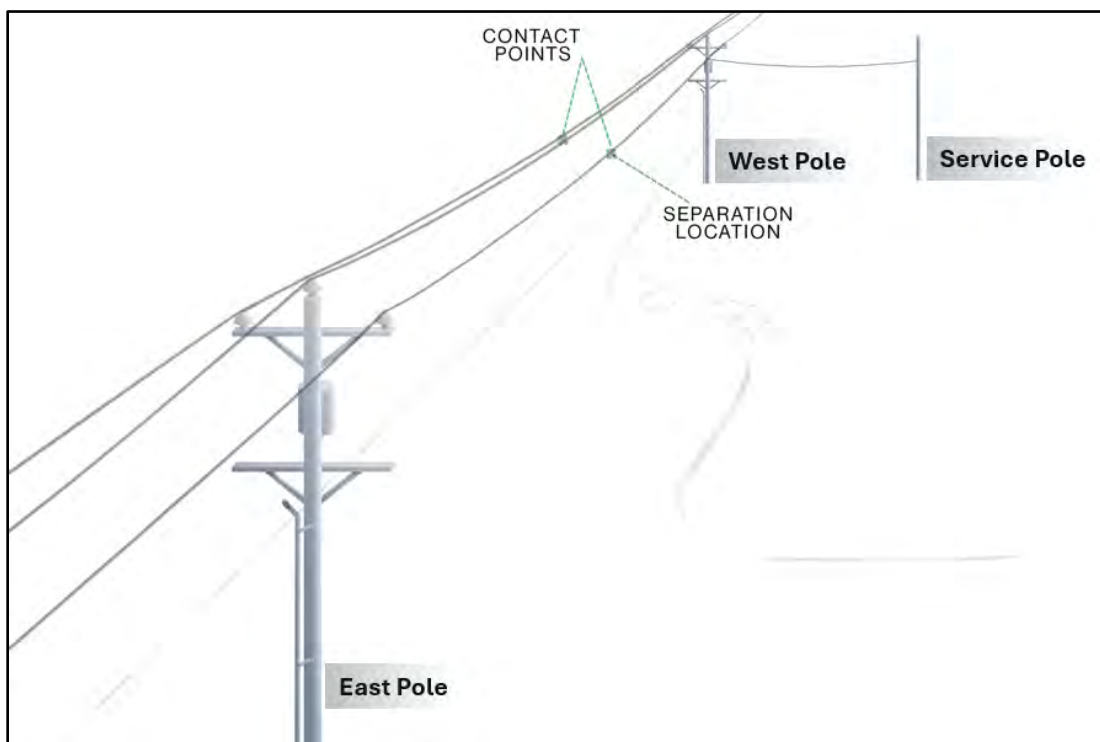
Figure 4: Simplified Illustration of Contact Points and Separation Location

4 The center and field phase conductors show evidence of recent arcing consistent with
5 phase-to-phase contact on November 17, 2020. The area of contact was approximately mid-span
6 between the West and East Poles, including at the location where the field phase conductor
7 ultimately separated and fell to the ground.⁸ The field phase conductor exhibited arcing and
8 melting on each end of the separation point. In particular, there was melting on every aluminum
9 strand at all points of separation, including the steel core strand. The lack of oxidation and
10 overall appearance of this evidence indicates that the damage is fresh and occurred shortly before
11 the conductor was removed from the field. The center phase conductor also exhibited areas of
12 arcing. The most pronounced area aligns with the location of the field phase conductor
13 separation, indicating that the two conductors came into contact. Unlike the field phase

14 conductor, however, the steel core of the center phase conductor remained intact and the
15 conductor did not separate or fall to the ground, though some of the individual aluminum strands
16 separated due to arcing and melting. The center and field phases did not exhibit evidence of old
17 arcing.

18 The west end of the field phase conductor also exhibited discoloration, likely due to the
19 ground fire. The evidence indicates the west side of the field phase conductor contacted another
20 metal wire—likely the bare neutral wire associated with the triplex conductor between the West
21 Pole and a service pole to its north and a guy wire supporting the West Pole. The east end of the
22 field phase conductor exhibited mechanical damage. The conductor east of the separation point
23 was de-energized due to the separation and apparently fell to the ground in a gravel parking area,
24 where I understand it was driven over by multiple vehicles.

⁸ The conductor's point of separation was approximately 135 feet, 8 inches from the West Pole.
