# **Mountain View Fire Cost Recovery Application**

Before the California Public Utilities Commission

**Liberty-03: Prudence of Operations**

June 20, 2025

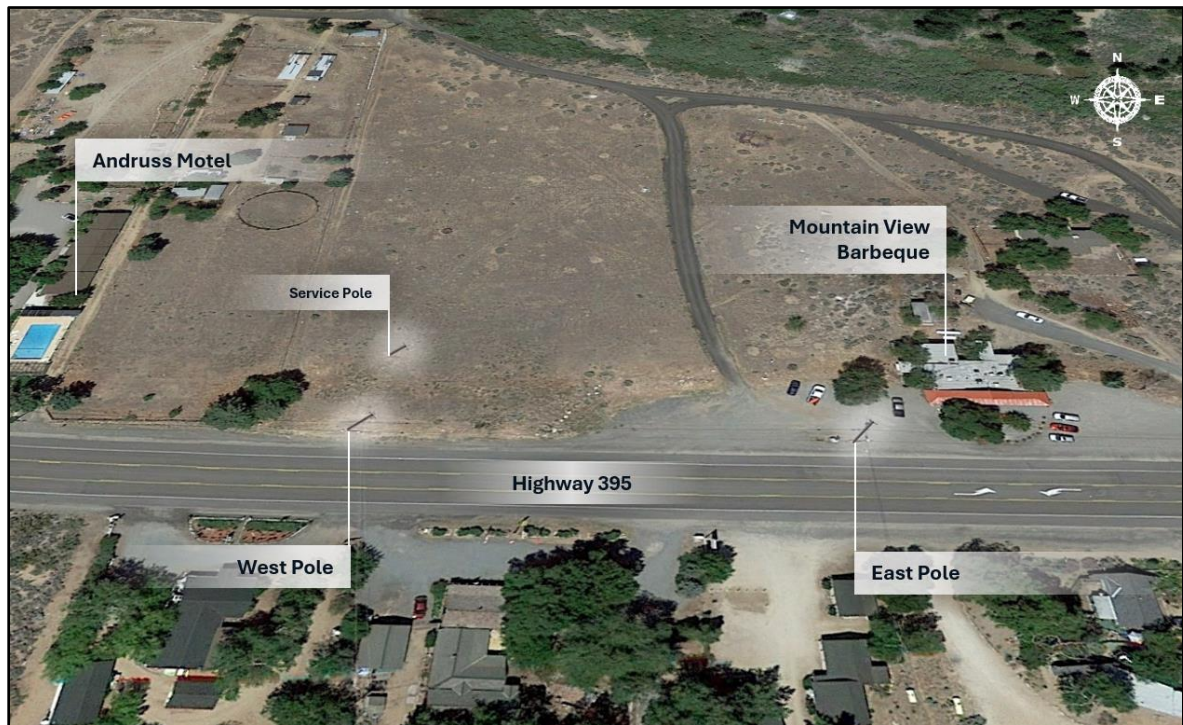
***Figure 2: Liberty Facilities Near the Origin Area of the Mountain View Fire***

1 the “most probable cause” of the Mountain View Fire as an “energized conductor contacting the  
2 ground” and igniting cured annual grasses.<sup>6</sup> Liberty’s facilities adjacent to the origin area identified by  
3 the fire agency report are part of the Topaz 1261 Circuit and specifically include the span between Pole  
4 266731 (the “West Pole”) and Pole 40288 (the “East Pole”), or the “Subject Span.”

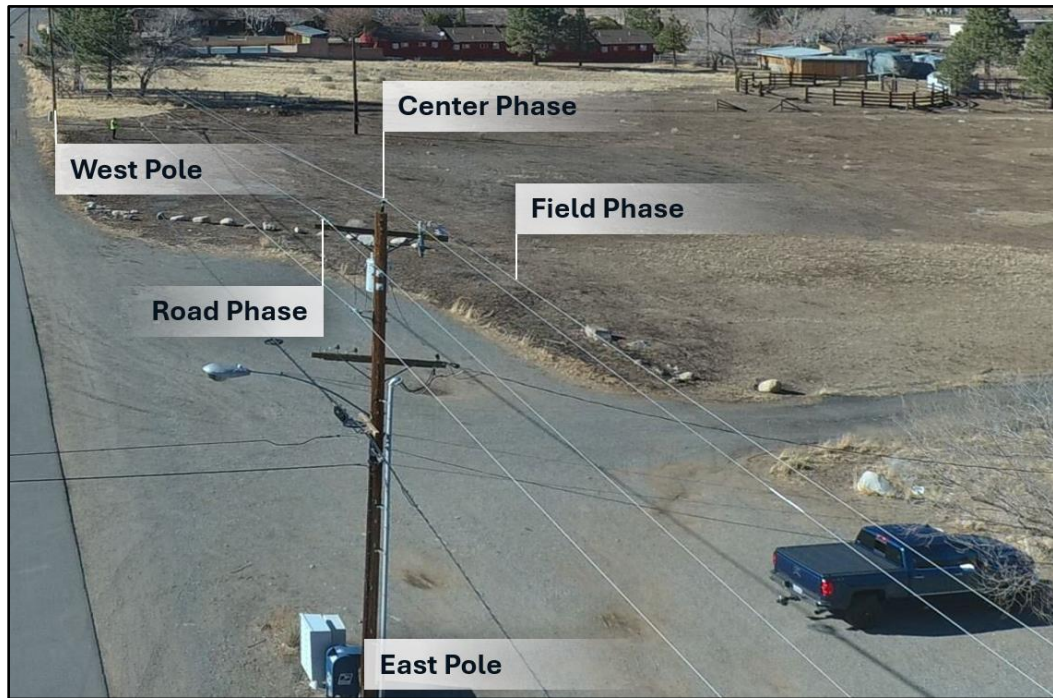
***Figure 3: Post-Fire Image of Triangular Crossarm Configuration of 1261 Topaz Circuit Over the Origin Area of the Mountain View Fire***

1        The distribution conductors on the Subject Span are arranged in a triangular crossarm  
2 configuration, with the outside phases attached to insulators mounted on crossarms and the center phase  
3 elevated and attached to an insulator mounted on the top of the poles. The neutral wire is attached to  
4 horizontal insulators mounted to the pole. The conductors on the Subject Span were #4 ACSR  
5 (Aluminum Conductor Steel Reinforced), which has a steel core surrounded by aluminum strands.  
6 Figure 3 through Figures 4 (Top) and 5 (Bottom): Simplified Graphics Illustrating Configuration of  
7 Equipment on the East and West Poles below illustrate the Subject Span and the Specific Facilities.

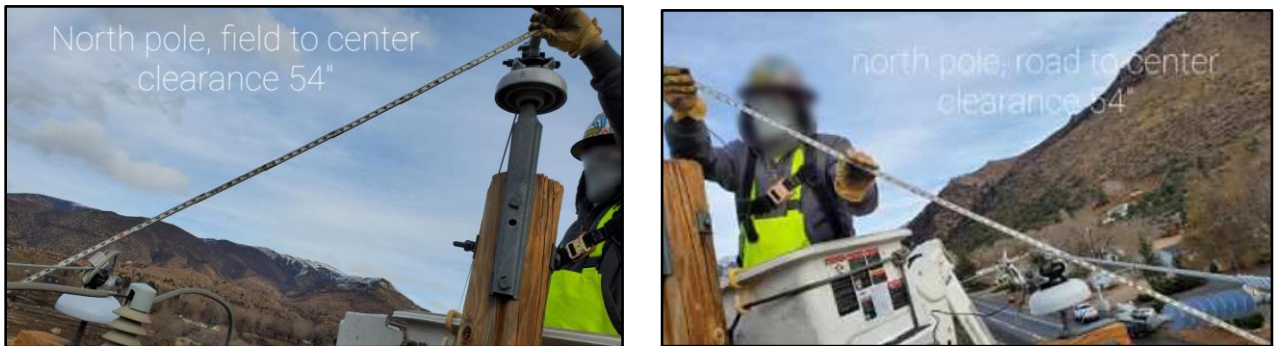
**Figures 6 (Left) and 7 (Right): Post-Fire Conductor Radial Clearance Measurements at West Pole<sup>17</sup>**

The Specific Facilities' conductor clearances at the West Pole were consistent with Liberty's standards and exceeded GO 95 requirements. As noted above, the triangular crossarm configuration provided increased separation between the phase conductors, as well as the neutral wire. The center phase conductor was mounted to an insulator attached to the top of the East and West Poles, while the outer phase conductors were attached to insulators mounted at either end of 8-foot crossarms. Triangular crossarm construction remains consistent with Liberty's Overhead Electric Standards.<sup>15</sup> For this type of construction on distribution facilities, GO 95 mandates a minimum horizontal separation of 17.5 inches between conductors, with the elevated center phase having a vertical separation at least equal to the pin spacing for the voltage class (*i.e.*, 17.5 inches).<sup>16</sup> Post-fire measurements recorded radial clearances of 54 inches between center and road and field phases at the West Pole. Liberty's standards for both poles utilized 8-foot cross arms, with insulators mounted at pre-fabricated through-holes approximately four inches from either end of the crossarms. Based on these dimensions and configuration, the calculated horizontal and vertical clearances at the East and West Poles exceeded of GO 95's requirements.

<sup>17</sup> Distance of 54 inches between the center and road phase conductors (left photograph) and between center and field phase conductors (right photograph).

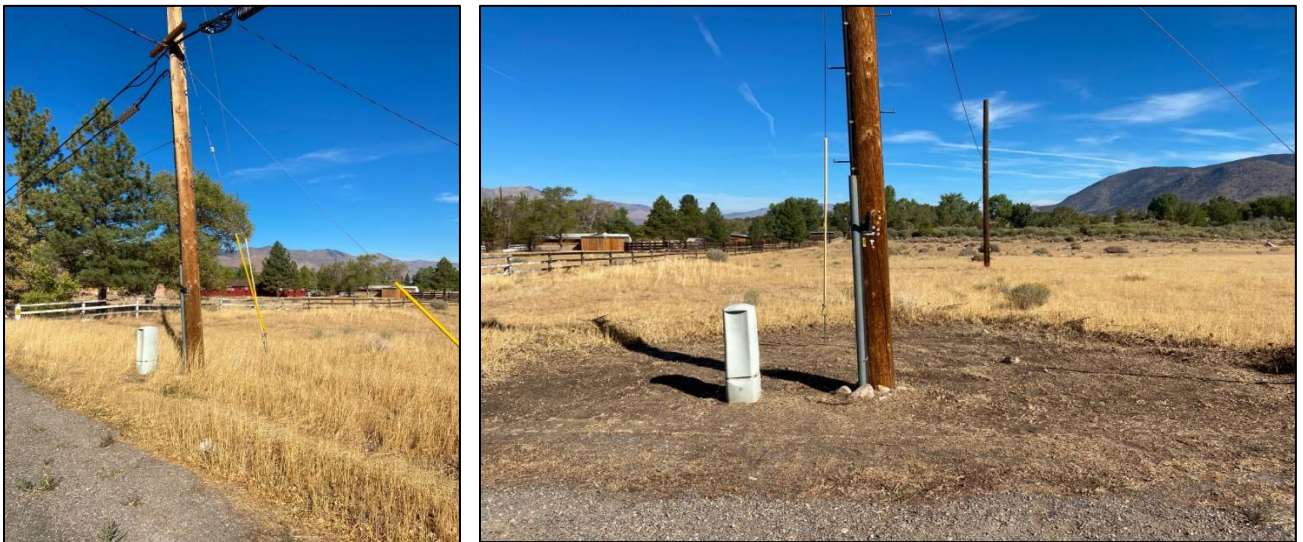
***Figure 13: Photographs of West Pole Before and After September 23, 2020 Pole Clearing***

<sup>40</sup> Appendix A to *Liberty-02C: Ignition*, at 17 (“Both power poles were in compliance with California Public Resource Code (PRC) Section 4292 and PRC Section 4993 [sic] requirements.”).
