Docket	:	<u>A.25-06-017</u>
Exhibit Number	:	<u>CA-05A</u>
Commissioner	:	<u>M. Baker</u>
Admin Law Judge	:	<u>R. Haga</u>
Witness	:	<u>A. Asadi</u>

**PUBLIC ADVOCATES OFFICE
CALIFORNIA PUBLIC UTILITIES COMMISSION**

**TESTIMONY ON
PREVENTIVE MEASURES FOR WILDFIRE RISK
FOR MOUNTAIN VIEW FIRE
COST-RECOVERY APPLICATION**

Reasonableness of Operations Prior to Ignitions

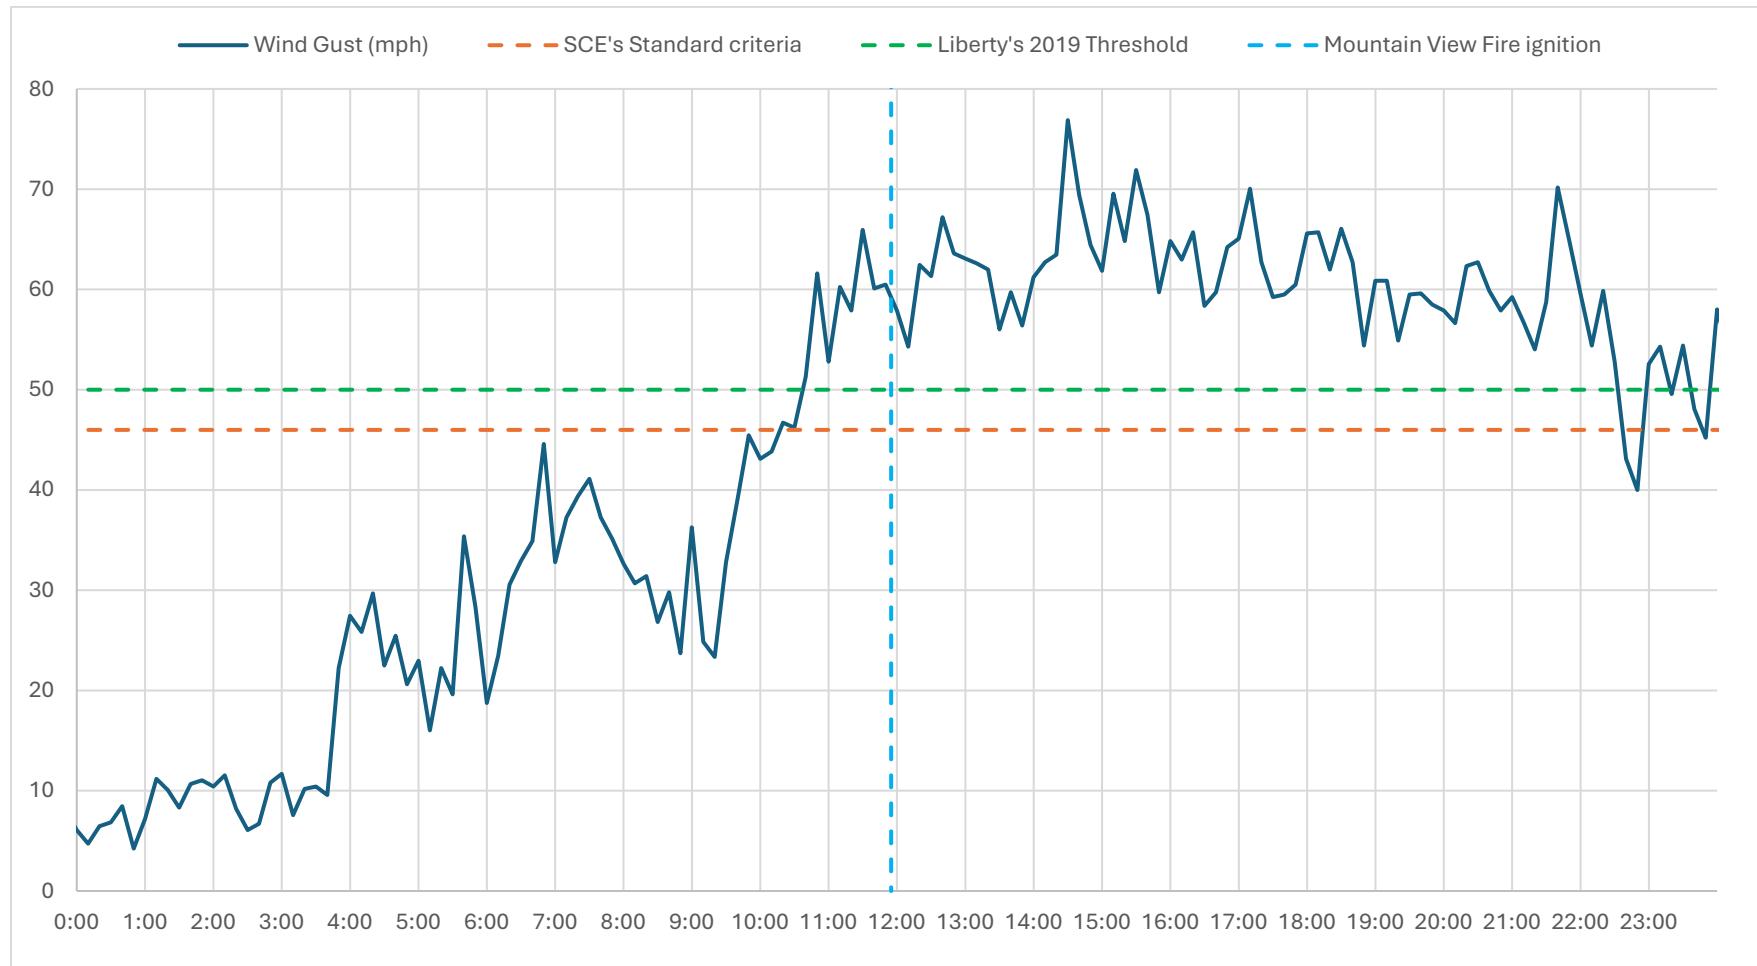
Figure 2:
Graph of wind gust speeds on Topaz 1261 circuit on November 17, 2020.²⁴

6 On the morning of November 17, 2020, at 9:48am, Liberty’s Topaz 1261 circuit
7 experienced a suspected wire slapping event,¹⁶⁰ which caused an outage¹⁶¹ that occurred
8 at a wind gust speed of approximately 45.5 mph.¹⁶² Notably, this wind gust speed
9 approached Liberty’s wind gust forecast (approximately 45 mph, which was incorrectly
10 shown as below the 100% threshold)¹⁶³ (see Figure 11 below) and surpassed Liberty’s
11 PSPS criteria predefined wind gust threshold (45 mph).¹⁶⁴ This should have alarmed
12 anyone monitoring the system. Indeed, this warranted a risk assessment.

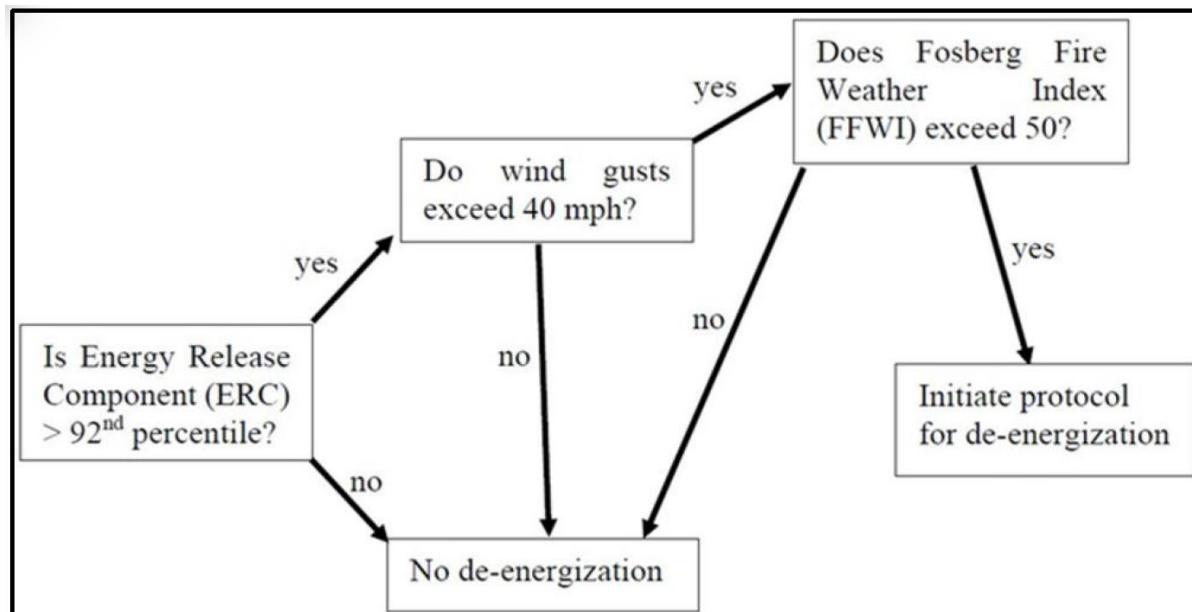
11 **Figure 3:**
12 **Liberty’s De-energization decision tree for most of Liberty’s PSPS Zones**
13 **(excluding the Topaz 1261 and Muller 1296 circuits).**⁶⁷

3 Liberty hired a “fire science and risk modeling consultant in 2019 to support
4 developing a more sophisticated PSPS protocol comprising a set of criteria and guidelines
5 for de-energization.”⁶⁵ Liberty’s new PSPS protocol “used a predictive tool to capture
6 three fire weather components: (a) Energy Release Component (‘ERC’); (b) wind gusts;
7 and (c) Fosberg Fire Weather Index (‘FFWI’).”⁶⁶ Figures 3 and 4 below show Liberty’s
8 de-energization decision trees. Liberty assigned a higher wind gust threshold and higher
9 FFWI threshold for the Topaz 1261 and Muller 1296 circuits (Figure 4) than the rest of
10 Liberty’s circuits (Figure 3).

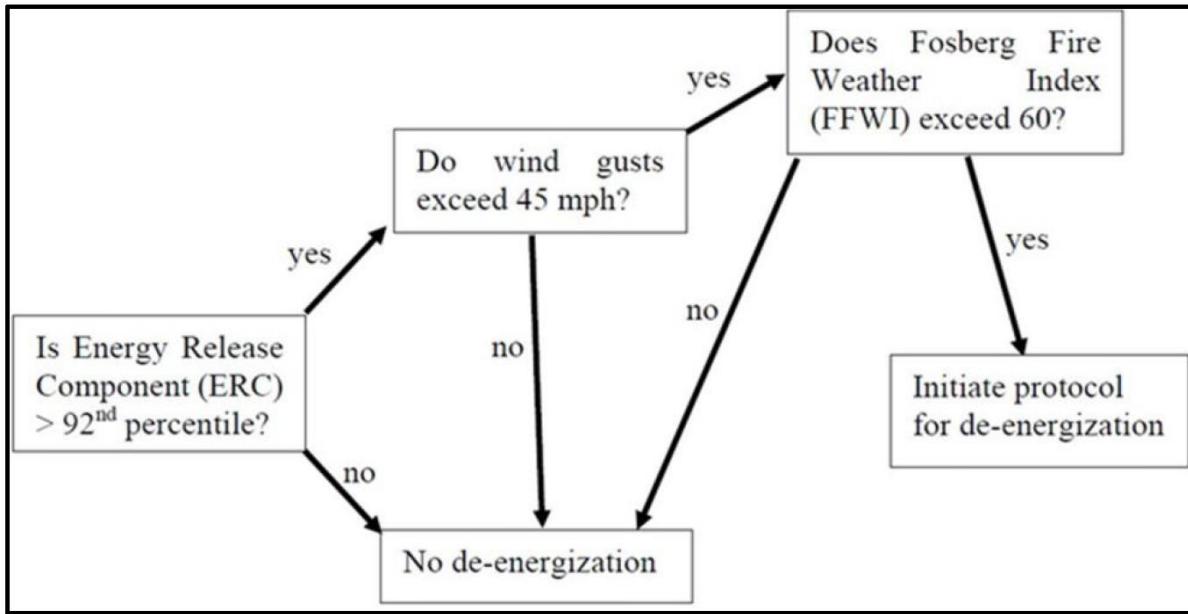
Figure 4:
Liberty's De-energization decision tree for only Liberty's Topaz 1261
and Muller 1296 circuits.⁶⁸

16 Liberty states that because the “Topaz and Muller 1296 R3 PSPS zones were
17 windier than other PSPS zones under normal weather conditions, Liberty’s protocol
18 established slightly higher thresholds for wind gusts.”⁹¹ Liberty’s consultant, Reax
19 Engineering, determined that Liberty’s wind gust threshold for Topaz and Muller 1296
20 circuits should be higher than the “baseline values established earlier due to consistently
21 higher wind speeds in these areas.”⁹² However, Section C shows in detail Liberty’s
22 history of wire slap related outages and how approximately 27% of those outages
23 occurred at wind speeds lower than 40 mph and 44% of those outages occurred at wind
24 speeds lower than 45 mph. Liberty’s and REAX’s decision to increase the wind speed

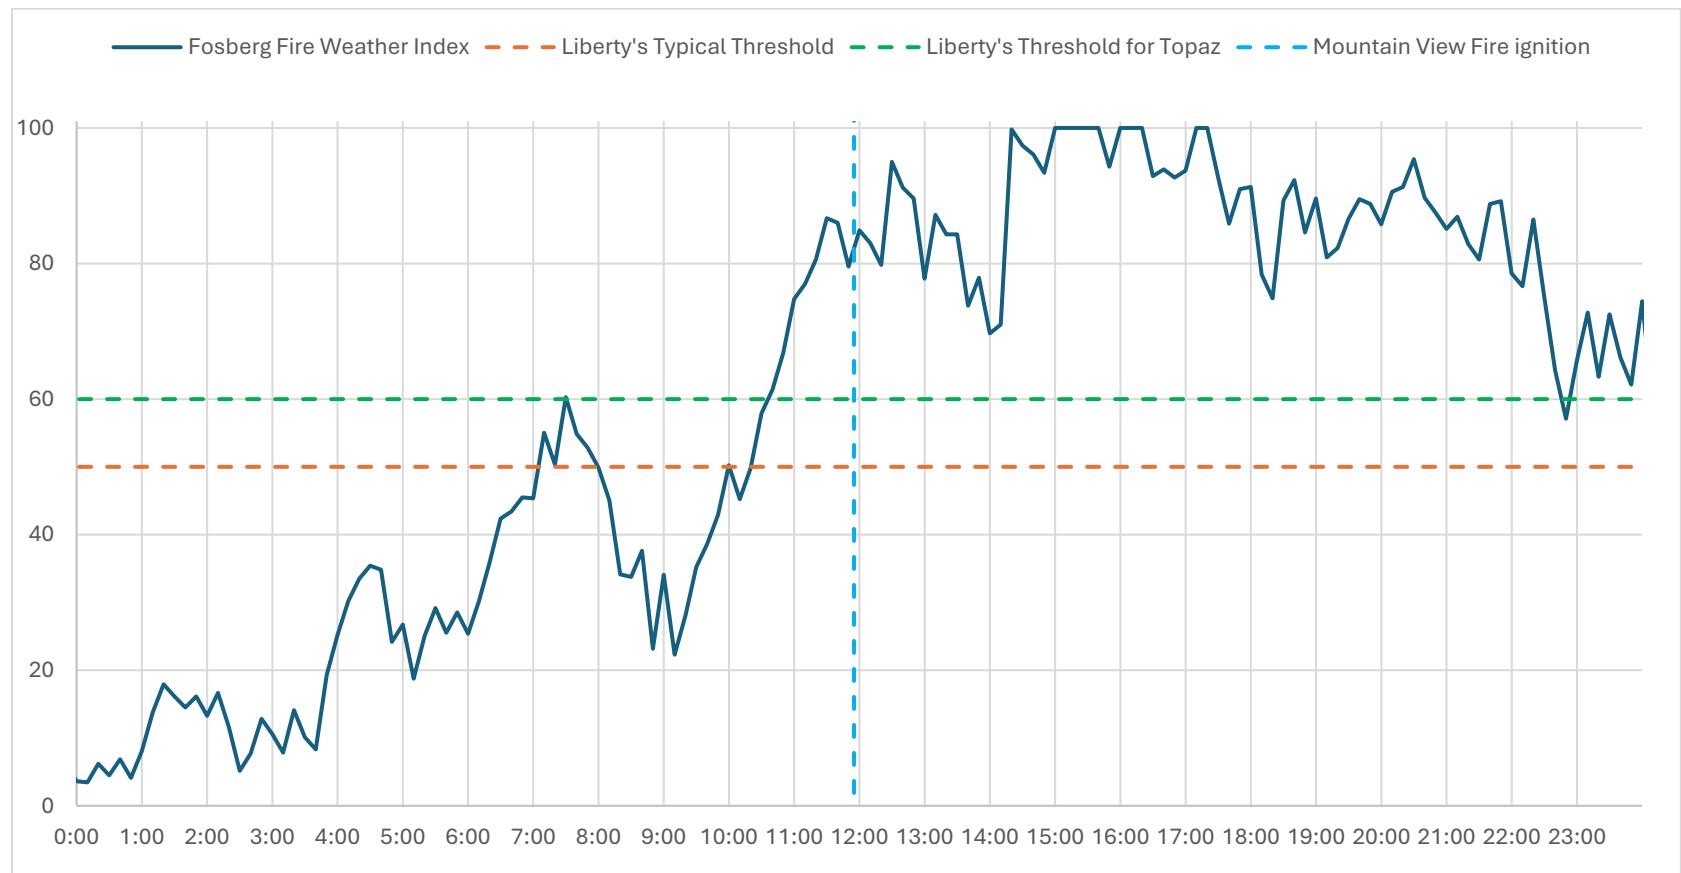
1
2 **Figure 5:**
Liberty's Fosberg Fire Weather Index as calculated by its LIB-26 weather station on November 17, 2020.¹⁰²

1 threshold of 60 for Topaz. Figure 5 below shows that the real-time calculation for
2 Fosberg Fire Weather Index hit Liberty's threshold for Topaz at 7:30 am and then again
3 exceeded this threshold at 10:40 am and stayed above this value through the time of the
4 Mountain View Fire ignition.

7 Liberty had available the real-time FFWI¹⁰⁵ that could proxy RFW conditions at
8 the local level,¹⁰⁶ but instead Liberty relied on regional weather forecasts¹⁰⁷ and
9 positioned FFWI as third in its decision tree, thus making it a lower priority in its
10 decision-making process.

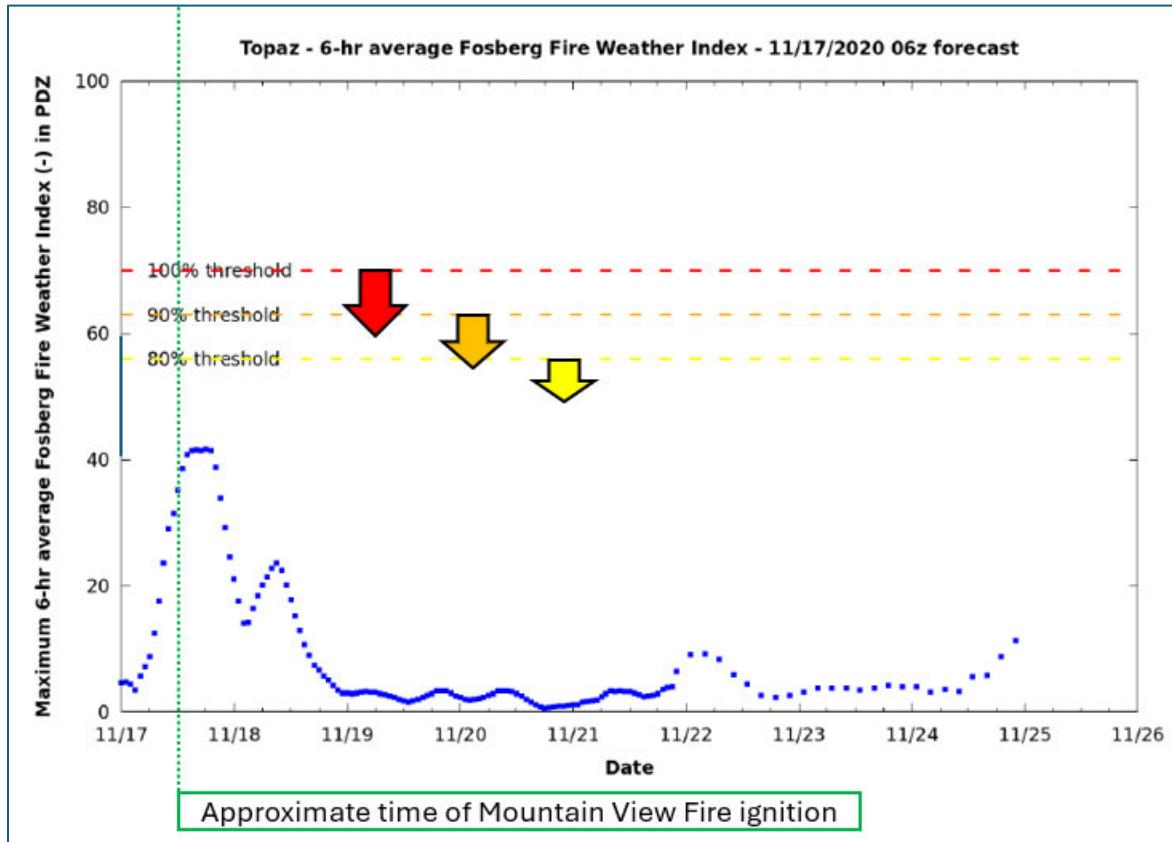
Figure 7:
Liberty's fire weather dashboard forecast for Topaz zone's FFWI at 6:00am on November 17, 2020.¹¹⁶

5
6 Tables 6 and 7 above demonstrate that Liberty's fire weather dashboard failed to
7 correctly indicate that the forecasts were reaching 80%, 90% or 100% of the threshold for
8 Topaz and Muller zones. For all circuits, the dashboard did not provide any indication of
9 the ERC percentile forecast reaching 80%, 90%, or 100% of the threshold of the 92nd
10 percentile.

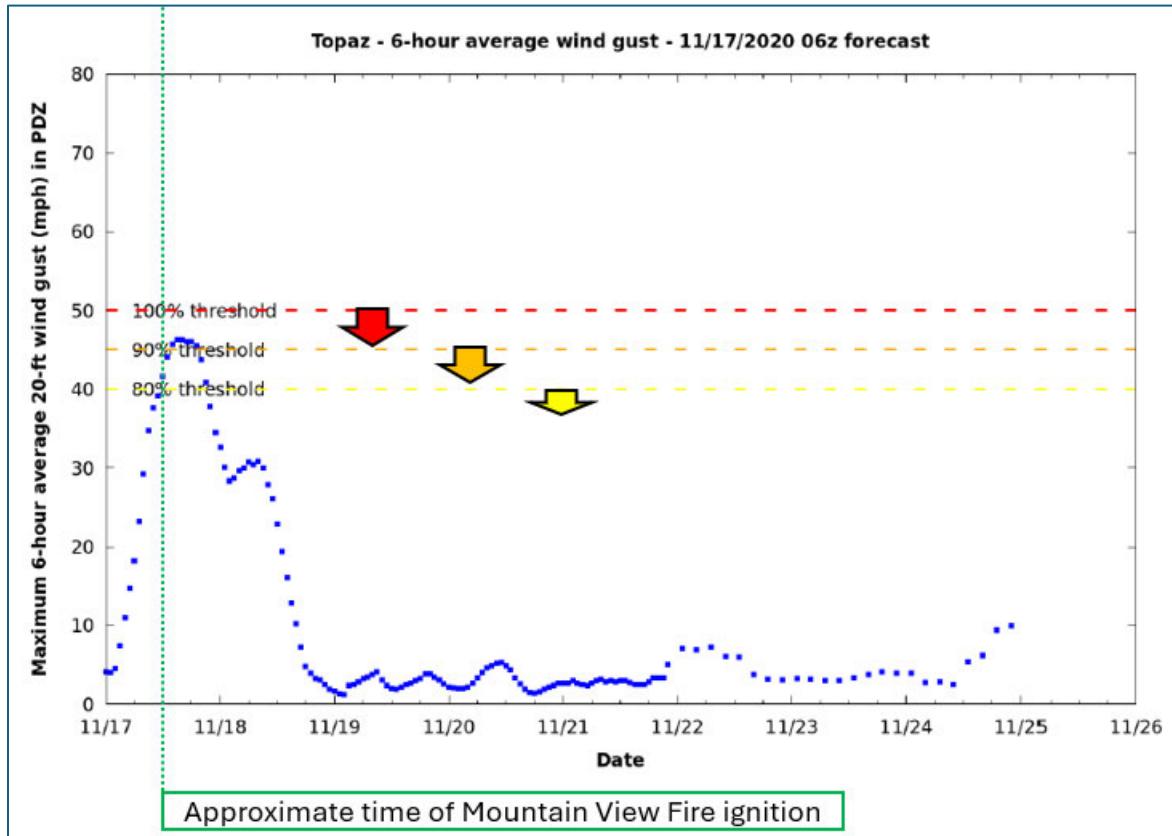
1
2 **Figure 8:**
3 **Liberty's fire weather dashboard forecast for Topaz zone's wind gust at 6:00am on**
November 17, 2020.¹¹⁷

5 As can be seen in Figure 8, which shows the wind gust forecast for the Topaz zone
6 on November 17, 2020 at 6:00 am, this incorrect representation of the threshold values
7 makes interpretation of the graphs difficult. The dotted blue curve represents the
8 forecasted wind gust values while the dashed red, orange, and yellow lines are what
9 Liberty's fire weather dashboard actually displayed. The red, orange, and yellow arrows
10 were added to this image to show where the dashed lines respectively should have been.
11 The dotted green line was added to this image to show when the Mountain View Fire
12 would approximately occur.
