Docket	:	<u>A.25-06-017</u>
Exhibit Number	:	<u>CA-07</u>
Commissioner	:	<u>M. Baker</u>
Admin Law Judge	:	<u>R. Haga</u>
Witness	:	<u>C. Madison</u>

PUBLIC ADVOCATES OFFICE
CALIFORNIA PUBLIC UTILITIES COMMISSION

**TESTIMONY ON
OPERATIONS
FOR MOUNTAIN VIEW FIRE
COST-RECOVERY APPLICATION**

Reasonableness of Operations Prior to Ignitions

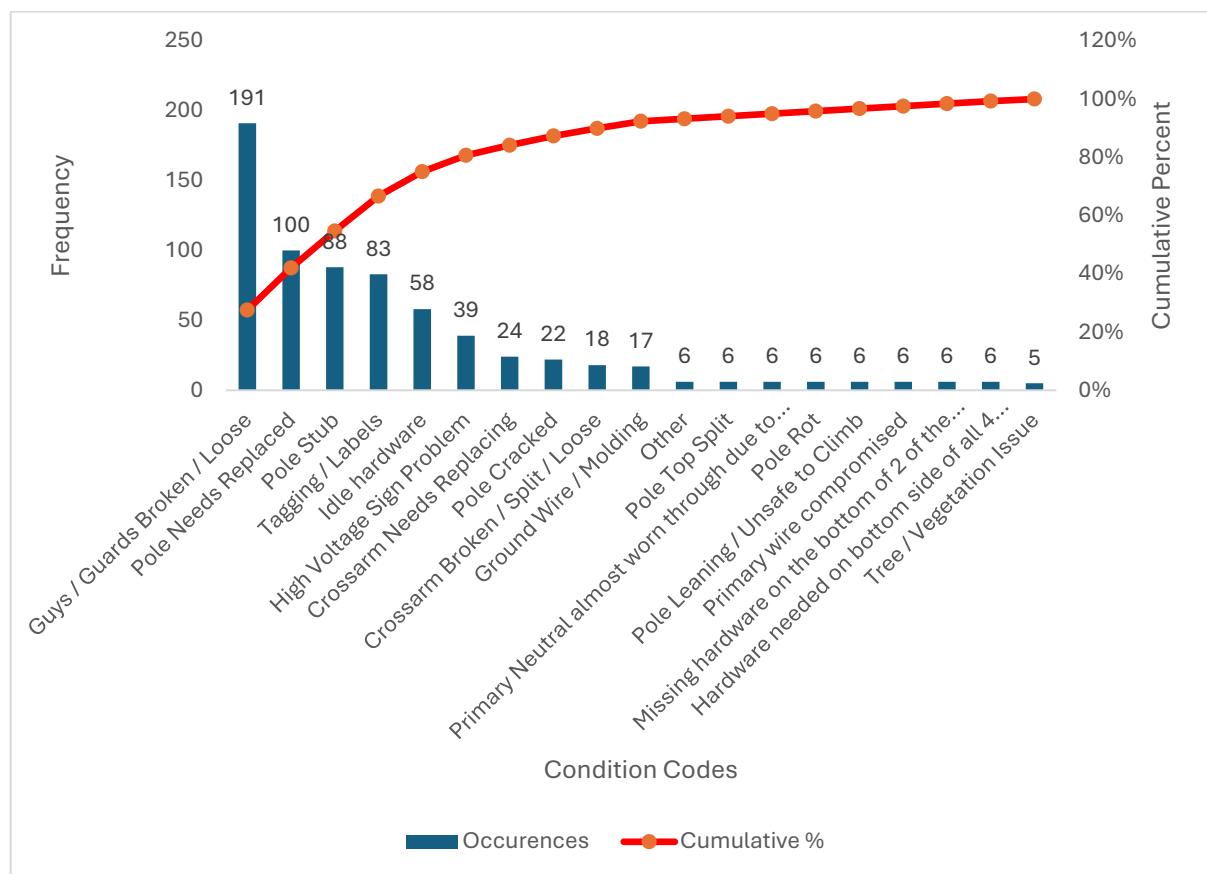
7 **Figure 1:⁶²**
8 **Results of 2020 Asset Survey: Topaz 1261 Circuit**

4 The condition code data makes the pattern unmistakable. Figure 1 shows the
5 conditions identified on Topaz 1261 circuit during its 2020 Asset Survey, organized from
6 most to least common.

10 Figure 1 also illustrates that the Topaz circuit's condition issues were highly
11 concentrated in a small number of defect categories, several of which are associated with
12 direct reliability or safety risk. The fact that more than half of all observed defects fall

3 Of the 19 unique condition types, the most common were some of the most
4 serious: “Guys/Guards Broken/Loose” (191), “Pole Needs Replaced” (100), “Pole Stub”
5 (88), “Pole Cracked” (34), and “Crossarm Needs Replacing” (24).⁶⁴ These are not
6 superficial issues. They are direct indicators of potentially compromised structural
7 integrity. Altogether, inspectors documented (693) corrective findings on the Topaz
8 circuit.⁶⁵

9 This distribution is clear: a significant proportion of Topaz structures failed
10 inspection, and many required major corrective action, including full pole replacement.

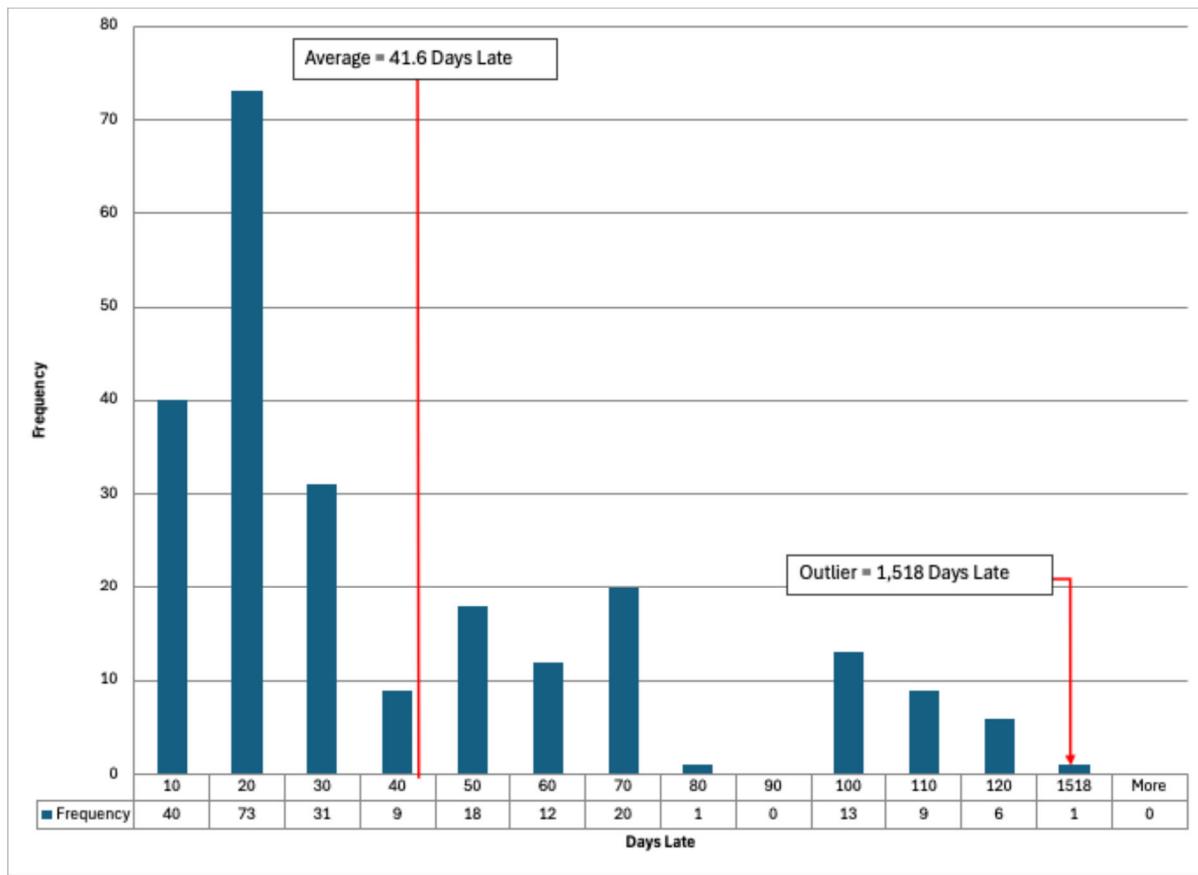
Figure 2:
Late 2020 Asset Survey Corrections

7 Evidence of Liberty's delays in addressing known safety issues is reflected
8 directly in its own 2020 Asset Survey data for the Topaz circuit. Liberty completed 233
9 corrective repairs.⁷⁰ In fact, 17% of all Topaz circuit corrective repairs were completed
10 past their GO 95 mandated deadlines.⁷¹

1 This is a measurable pattern showing that a portion of identified hazards remained
2 in the field longer than allowed under Liberty's own standards and regulatory
3 requirements. In addition, as discussed above, Liberty often bundled high-priority
4 maintenance work with low-priority maintenance work, which could lead to high-priority
5 work being deferred longer than was safe or appropriate. When taken in conjunction with
6 Liberty correcting 17% of repairs after their deadlines, it is likely that medium and high-
7 priority issues were completed on an unsafe timeline.⁷³
