Docket	:	<u>A.25-06-017</u>
Exhibit Number	:	<u>CA-06</u>
Commissioner	:	<u>M. Baker</u>
Admin Law Juge	:	<u>R. Haga</u>
Witness	:	<u>H. Eng</u>

PUBLIC ADVOCATES OFFICE
CALIFORNIA PUBLIC UTILITIES COMMISSION

**TESTIMONY ON
PRUDENCE OF OPERATIONS
FOR MOUNTAIN VIEW FIRE
COST-RECOVERY APPLICATION**

Reasonableness of Operations Prior to Ignitions

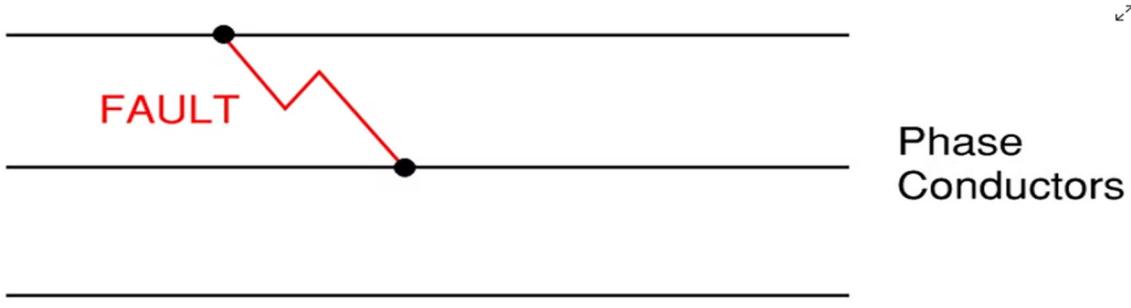
1 Figure 1: Phase-to-Phase Fault

20 Phase-to-phase faults occur when any two-phase conductors such as AB, BC, or
21 CA collide due to strong winds or vehicle hitting poles. In such cases the electric current
22 flows directly between two phases and increases sharply to many orders of the rated
23 current, which can result in significant voltage imbalance, damaging equipment and
24 affecting system stability.

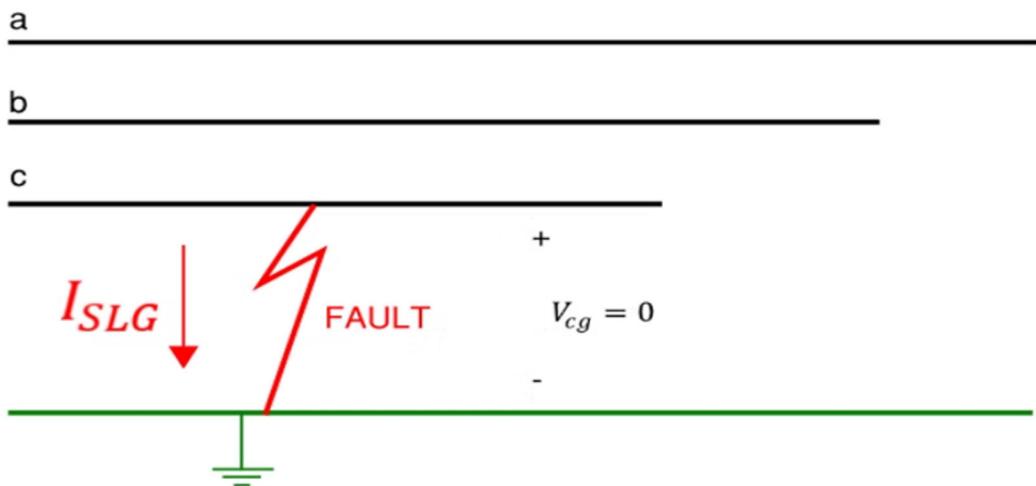
12 Figure 2: Phase-to-Ground Fault

4 Phase-to-ground faults occur when a phase conductor (A, B, or C) is accidentally
5 connected to the ground system (such as a tower, equipment housing, or the earth),
6 forming a low impedance path. The typical causes can be a conductor falling after
7 colliding with an adjacent conductor due to high winds or tree branches knocking down
8 the conductor. Ground faults are chaotic with respect to their fault currents, due to the
9 fact that the energized conductors are moving and the earth is a poor conductor.⁶ The
10 electric current thus increases dramatically leading to intensive heat, arcs and sparks and
11 escalating to the spread of wildfire.

1 Although both phase-to-phase short circuit and phase-to-ground faults are both
2 short circuit types, their fault paths are significantly different. Most importantly, the
3 magnitude of the fault current of the phase-to-ground fault is much higher than the phase-
4 to-phase fault current, thus making it more hazardous and destructive.

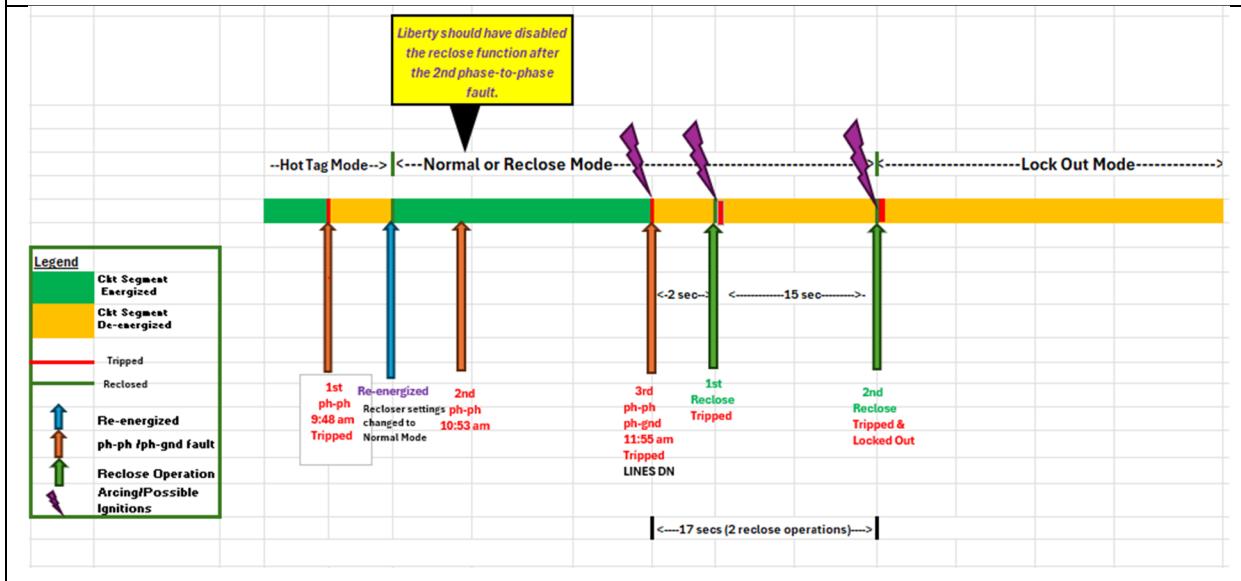
Figure 3 – Graphical Representation of the 1261 R2 Topaz Recloser Operations

16 The sequence of events⁹ is summarized in Table 1 and represented graphically in
17 Figure 3.

2 Three (3) consecutive phase-to-phase faults occurred in a matter of two hours on a
3 windy day, with the first two phase-to-phase faults occurring within 65 minutes. Each
4 phase-to-phase fault caused arcing and the conductor subsequently separated and fell to
5 the ground. The separation of the conductor was caused by melting due to arcing.¹⁰

6 At 9:48 a.m., the first phase-to-phase fault tripped and de-energized the circuit
7 segment downstream from R2 Recloser. At the time, the 1261 R2 Recloser was in
8 “hotline tag” mode for worker safety because reconductoring work on Liberty’s Topaz
9 Line Rebuild Project was ongoing.¹¹ Hotline Tag Mode means that the recloser would
10 not reclose if tripped. After the outage at 9:48 a.m. Liberty patrolled the line, and at
11 10:41 a.m. Liberty re-energized the circuit segment and disabled the hotline tag mode
12 and returned to “normal” mode, enabling the recloser’s reclose function.

13 At 10:53 a.m., the second phase-to-phase fault occurred but the recloser did not
14 trip because the fault current was of insufficient amplitude and duration for the recloser to

1 operate. The fault self-cleared,¹² and the circuit segment remained energized. Despite
2 the two consecutive phase-to-phase faults in high wind condition,¹³ Liberty decided to
3 leave the recloser settings in “normal” mode.

4 At 11:55 a.m., the third phase-to-phase fault occurred. Subsequently the C-phase
5 overhead conductor separated and fell to the ground and caused a phase-to-ground fault.
6 The R2 Recloser tripped the downstream circuit segment. Two seconds later at 11:55:22,
7 the recloser attempted to reclose but tripped again due to the existing phase-to-ground
8 fault. At 11:55:37, the recloser attempted to reclose again 15 seconds later but tripped
9 and locked out due to the prevailing phase-to-ground fault.

11 The Mountain View wildfire could likely have been prevented if Liberty had not
12 changed the reclose setting from fire mode to normal mode when re-energizing after the
13 9:48 a.m. fault, or if it had changed the reclose setting back to fire mode after the second
14 phase-to-phase fault at 10:53 a.m.

15 The fire mode setting could have prevented the R2 Recloser from reclosing after
16 the recloser tripped due to the phase-to-ground fault, which resulted from the third phase-
17 to-phase fault at 11:55 a.m. This third phase-to-phase fault caused the C-phase conductor
18 to fall and come in contact with the ground, leading to a phase-to-ground fault.
