Mountain View Fire Cost Recovery Application

Before the California Public Utilities Commission

Liberty-02: Ignition

INVESTIGATION REPORT

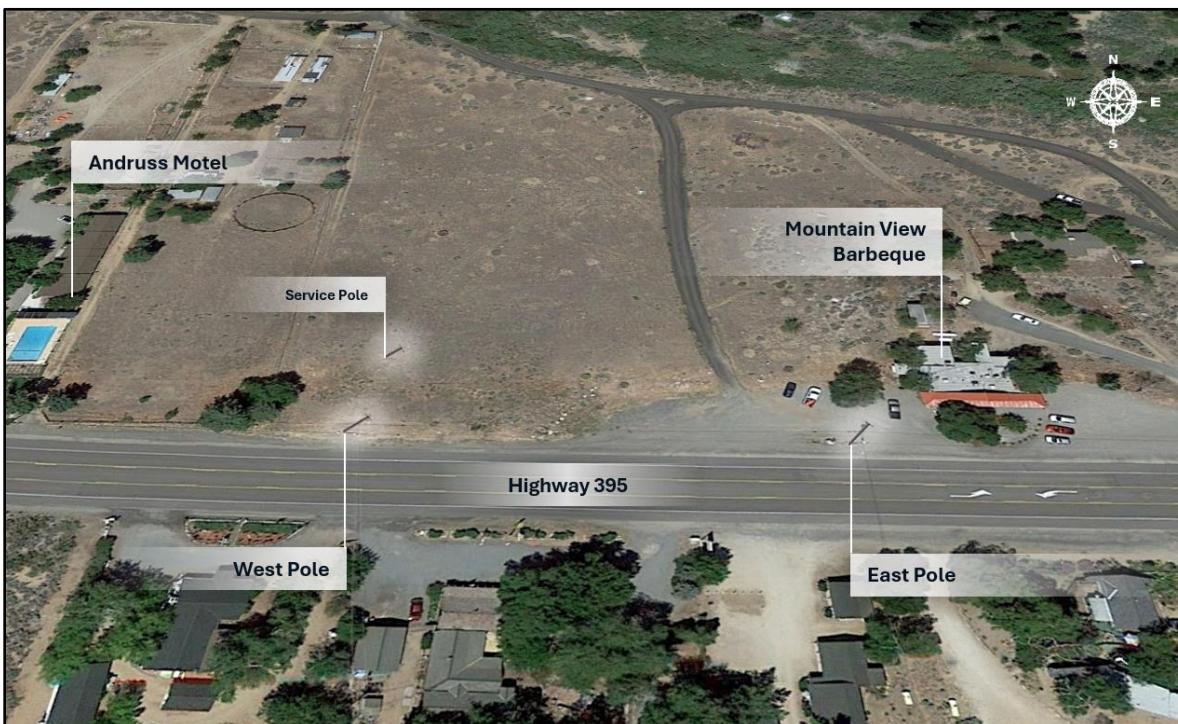
Figure 1: Origin Area of the Mountain View Fire

The Mountain View Fire ignited shortly before noon on November 17, 2020, near the town of Walker in Mono County, California. A 911 caller first reported the fire at approximately 11:58 a.m., and the fire was first observed in a grassy field adjacent to an area of Highway 395 that runs east and west. Cal Fire investigated the origin and cause of the Mountain View Fire and issued a report. Based on fire spread indicators, evidence collected, and witness statements, the report concludes that the “most probable” cause of the fire was an energized conductor contacting the ground and igniting grassy fuels between the East and West Poles.³ The origin area of the fire is shown in Figure 1.

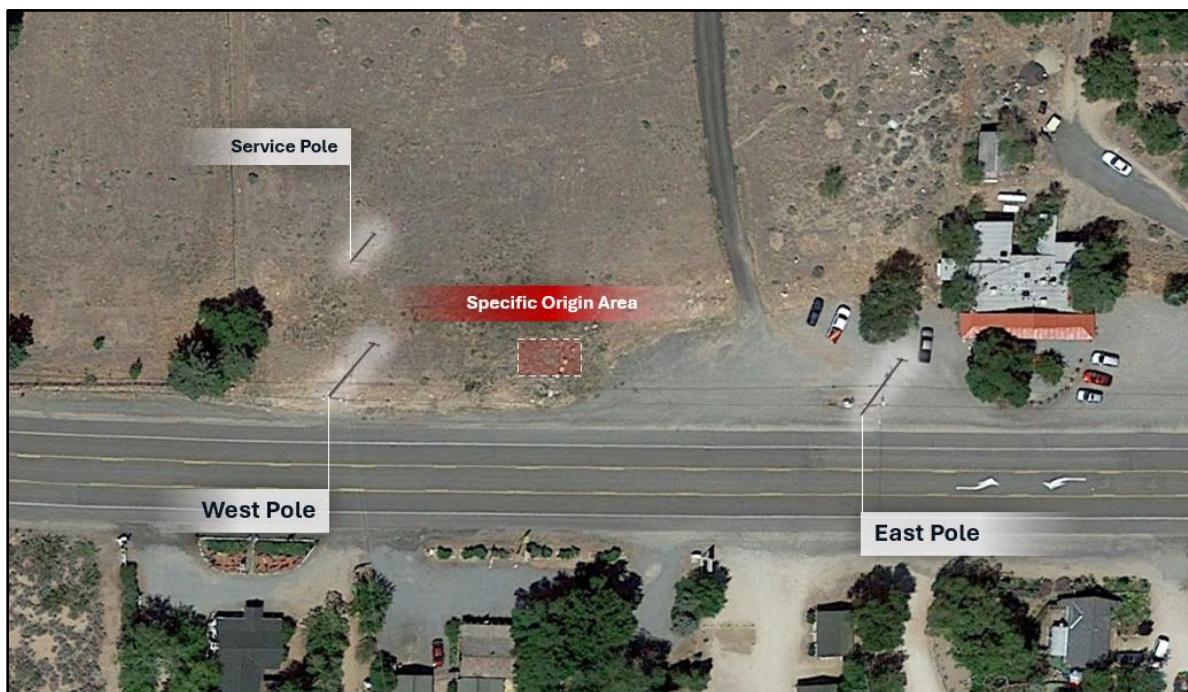
Figure 2: Specific Origin Area Identified by Fire Agency Report, with the West and East Poles Marked

1 lying on the ground adjacent to bleached rocks.⁵ The fire agency report indicates that investigators
2 mistakenly identified and focused on stains they thought were burn marks on rocks near this area and
3 indications of ignition, and failed to search for and consider further evidence. Smoke patterns on these
4 rocks, however, would have been indistinguishable between any arc flash and consumption of nearby
5 fuel by the fire, and were adjacent to vegetation that was consumed by the fire some time after its
6 ignition. Based on this, the fire agency report identified a specific origin area—a six feet by twelve feet
7 rectangular area near the end of the conductor and the burned rocks. This area is located between the
8 West and East Poles, just west of a parking turnout, as shown in Figure 2.⁶ This location, however,
9 appears unburned by an approaching flanking fire in photographic and video evidence captured by

10 eyewitnesses shortly after the fire began (Figure 3), further indicating that fire agency investigators did
11 not correctly identify the specific origin area of the fire.

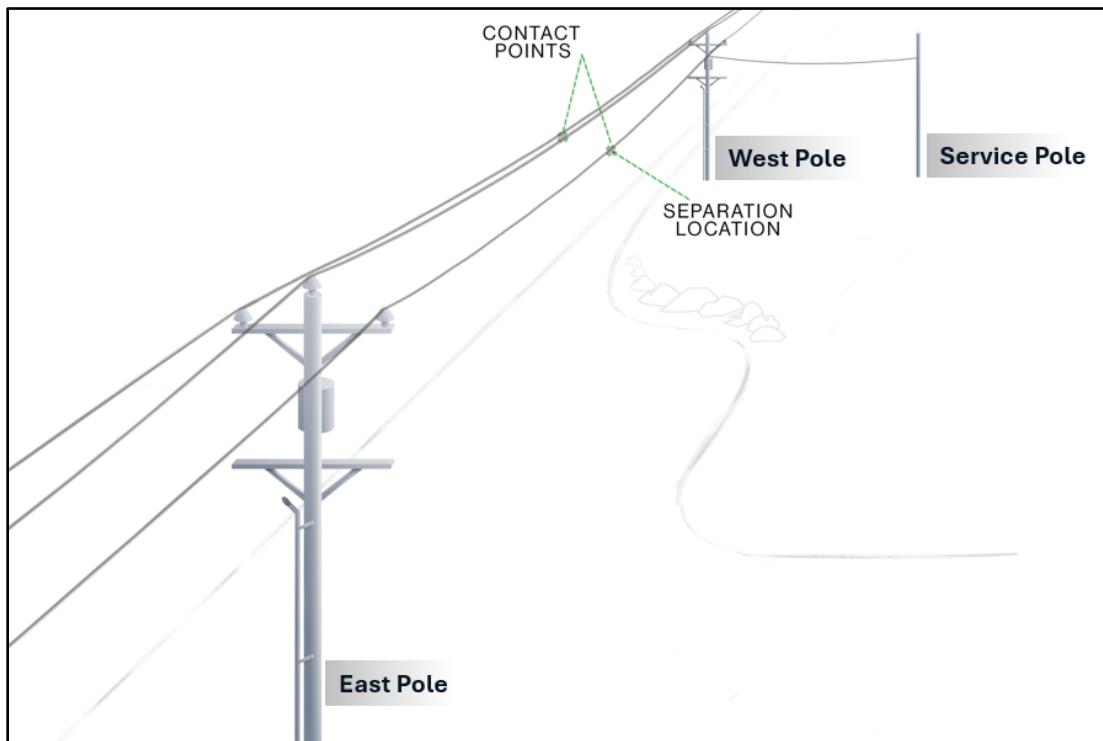
Figure 4: Simplified Illustration of Contact Points and Separation Location

4 The center and field phase conductors show evidence of recent arcing consistent with
5 phase-to-phase contact on November 17, 2020. The area of contact was approximately mid-span
6 between the West and East Poles, including at the location where the field phase conductor
7 ultimately separated and fell to the ground.⁸ The field phase conductor exhibited arcing and
8 melting on each end of the separation point. In particular, there was melting on every aluminum
9 strand at all points of separation, including the steel core strand. The lack of oxidation and
10 overall appearance of this evidence indicates that the damage is fresh and occurred shortly before
11 the conductor was removed from the field. The center phase conductor also exhibited areas of
12 arcing. The most pronounced area aligns with the location of the field phase conductor
13 separation, indicating that the two conductors came into contact. Unlike the field phase

14 conductor, however, the steel core of the center phase conductor remained intact and the
15 conductor did not separate or fall to the ground, though some of the individual aluminum strands
16 separated due to arcing and melting. The center and field phases did not exhibit evidence of old
17 arcing.

18 The west end of the field phase conductor also exhibited discoloration, likely due to the
19 ground fire. The evidence indicates the west side of the field phase conductor contacted another
20 metal wire—likely the bare neutral wire associated with the triplex conductor between the West
21 Pole and a service pole to its north and a guy wire supporting the West Pole. The east end of the
22 field phase conductor exhibited mechanical damage. The conductor east of the separation point
23 was de-energized due to the separation and apparently fell to the ground in a gravel parking area,
24 where I understand it was driven over by multiple vehicles.

⁸ The conductor's point of separation was approximately 135 feet, 8 inches from the West Pole.
