Mountain View Fire Cost Recovery Application

Before the California Public Utilities Commission

Liberty-02: Ignition

INVESTIGATION REPORT

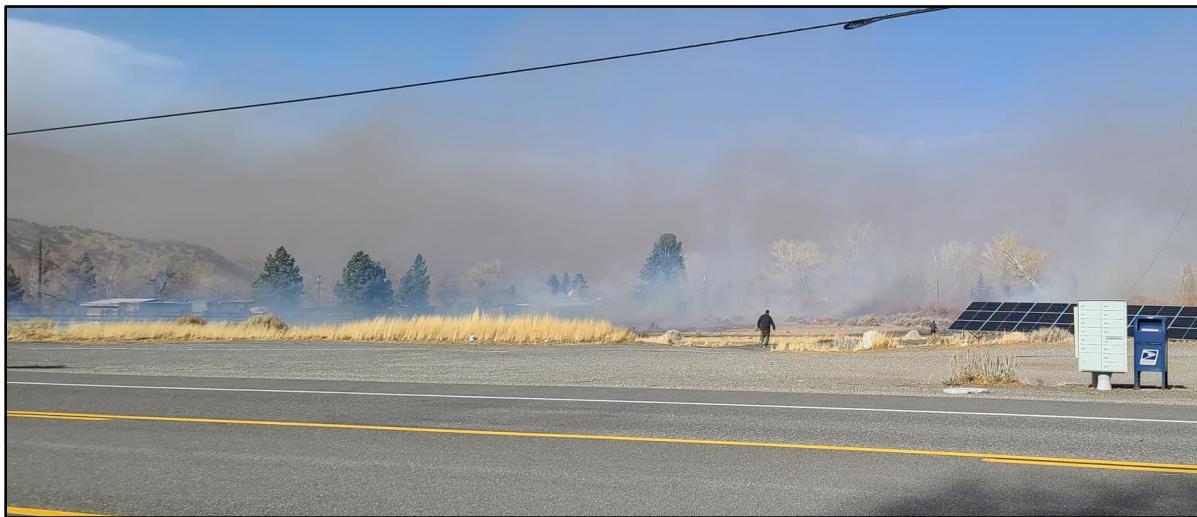
Figure 3: 12:01 p.m. Photograph of Specific Origin Area After Ignition

1 lying on the ground adjacent to bleached rocks.⁵ The fire agency report indicates that investigators
2 mistakenly identified and focused on stains they thought were burn marks on rocks near this area and
3 indications of ignition, and failed to search for and consider further evidence. Smoke patterns on these
4 rocks, however, would have been indistinguishable between any arc flash and consumption of nearby
5 fuel by the fire, and were adjacent to vegetation that was consumed by the fire some time after its
6 ignition. Based on this, the fire agency report identified a specific origin area—a six feet by twelve feet
7 rectangular area near the end of the conductor and the burned rocks. This area is located between the
8 West and East Poles, just west of a parking turnout, as shown in Figure 2.⁶ This location, however,
9 appears unburned by an approaching flanking fire in photographic and video evidence captured by

10 eyewitnesses shortly after the fire began (Figure 3), further indicating that fire agency investigators did
11 not correctly identify the specific origin area of the fire.
