Mountain View Fire Cost Recovery Application

Before the California Public Utilities Commission

Liberty-02: Ignition

Tahoe Vista, California June 20, 2025

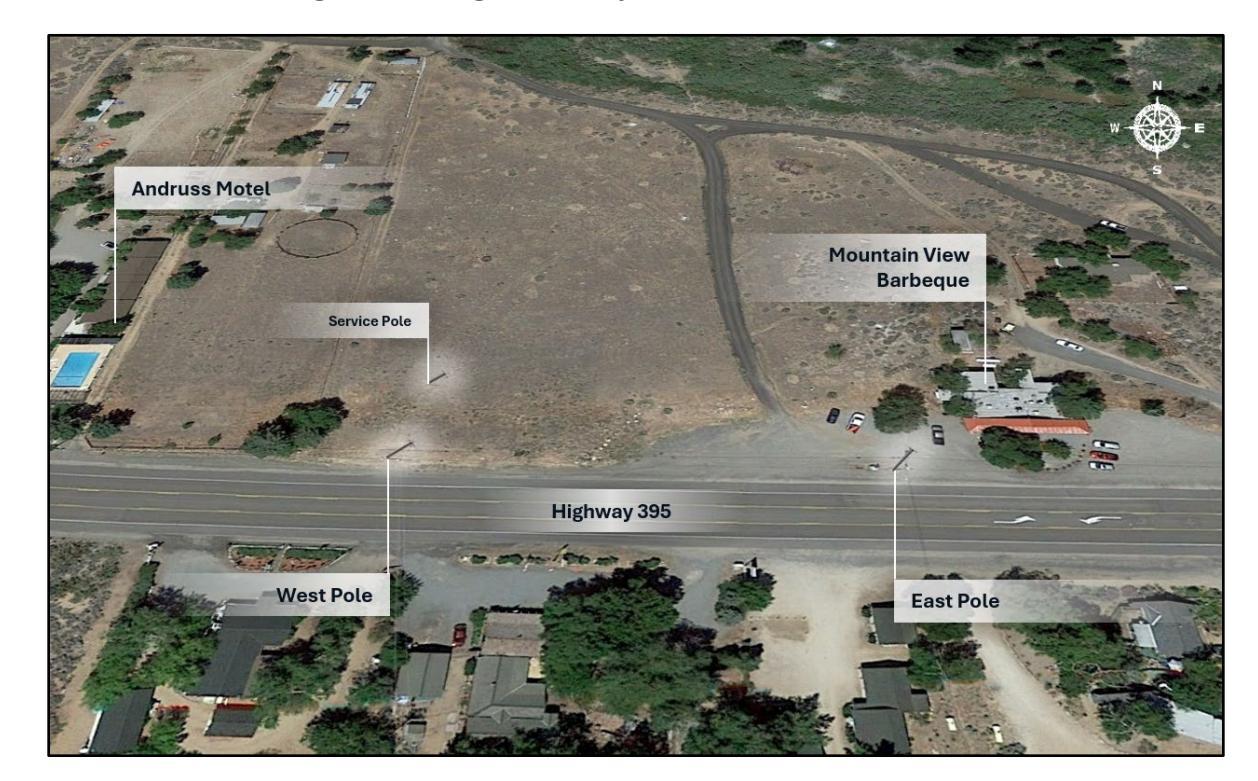
Figure 1: Origin Area of the Mountain View Fire

The Mountain View Fire ignited shortly before noon on November 17, 2020, near the town of Walker in Mono County, California. A 911 caller first reported the fire at approximately 11:58 a.m., and the fire was first observed in a grassy field adjacent to an area of Highway 395 that runs east and west. Cal Fire investigated the origin and cause of the Mountain View Fire and issued a report. Based on fire spread indicators, evidence collected, and witness statements, the report concludes that the "most probable" cause of the fire was an energized conductor contacting the ground and igniting grassy fuels between the East and West Poles.³ The origin area of the fire is shown in Figure 1.

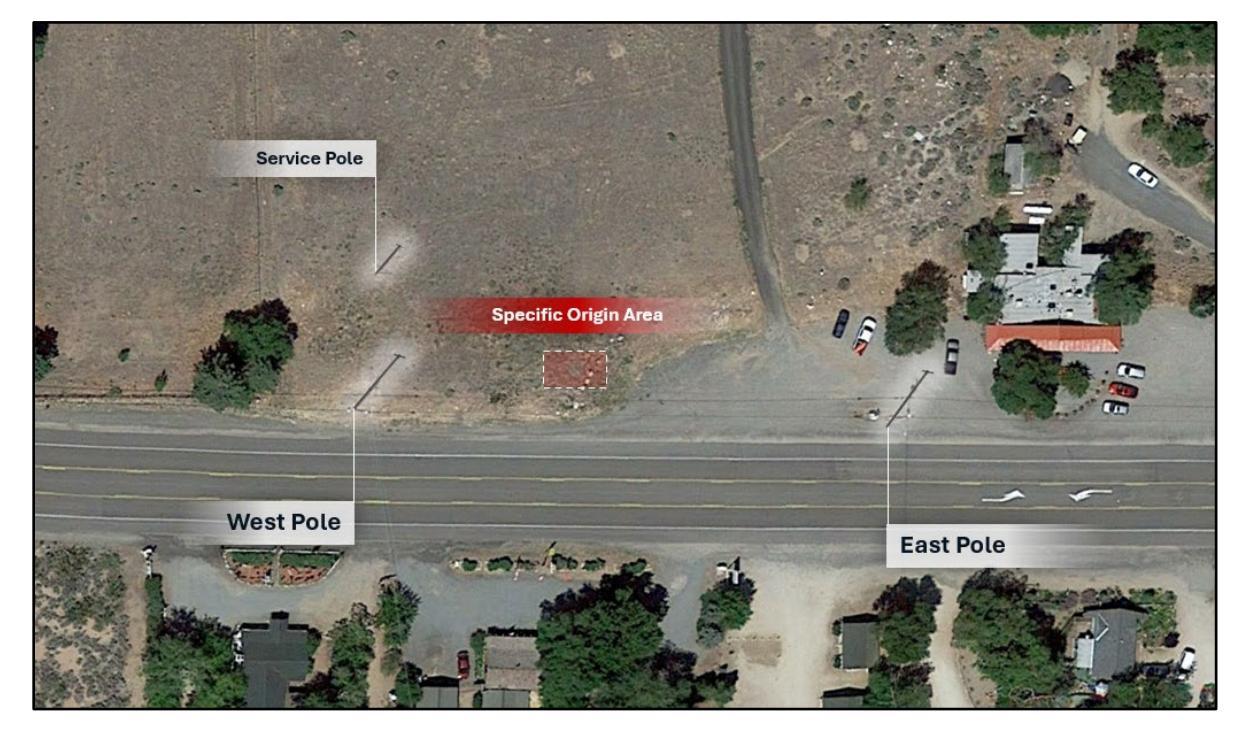
Figure 2: Specific Origin Area Identified by Fire Agency Report, with the West and East Poles Marked

Properly identifying a specific origin area is a critical step in the wildland fire investigative process. It is only after identifying a specific origin area that investigators should seek to identify the cause of the ignition within that specific origin area. Here, the investigators did not conduct a broad enough search to accurately identify a specific origin area. The only area the investigators appear to have examined thoroughly was the area of the field where a section of damaged conductor was found

lying on the ground adjacent to bleached rocks.⁵ The fire agency report indicates that investigators 1 mistakenly identified and focused on stains they thought were burn marks on rocks near this area and 2 indications of ignition, and failed to search for and consider further evidence. Smoke patterns on these 3 rocks, however, would have been indistinguishable between any arc flash and consumption of nearby 4 fuel by the fire, and were adjacent to vegetation that was consumed by the fire some time after its 5 ignition. Based on this, the fire agency report identified a specific origin area—a six feet by twelve feet 6 rectangular area near the end of the conductor and the burned rocks. This area is located between the 7 West and East Poles, just west of a parking turnout, as shown in Figure 2.⁶ This location, however, 8 appears unburned by an approaching flanking fire in photographic and video evidence captured by 9 eyewitnesses shortly after the fire began (Figure 3), further indicating that fire agency investigators did 10 not correctly identify the specific origin area of the fire. 11

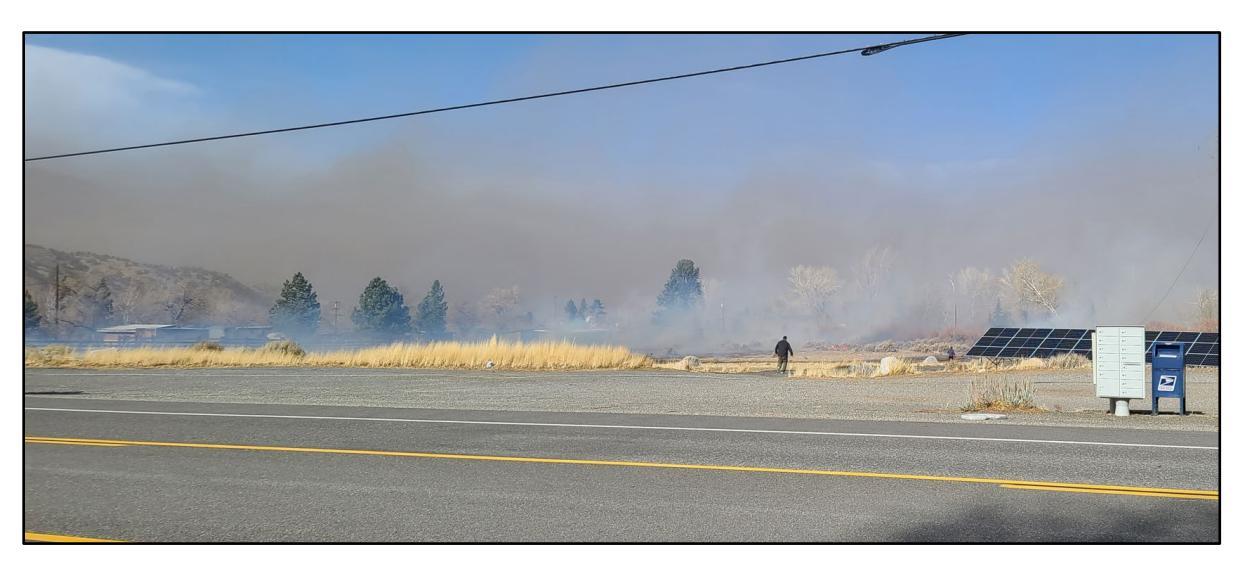
Figure 3: 12:01 p.m. Photograph of Specific Origin Area After Ignition

The fire agency investigation was complicated by environmental conditions, which impacted the 1 evidence available to fire agency investigators and, as a result, limited their ability to draw reliable 2 conclusions regarding the fire's origin and cause. High winds and rain in the area of origin following 3 ignition of the fire limited the quantity and availability of fire movement indicators that fire agency 4 investigators could analyze (though the rainfall aided fire suppression efforts, as described in *Liberty-04*: 5 *External Factors*).⁷ This rainfall occurred before fire agency investigators arrived on scene the day 6 following the ignition, and may have limited their ability to draw reliable conclusions from the 7 remaining markers. In standard wildland fire investigations, investigators meticulously identify, 8 document, and analyze a large number of fire movement indicators in and around the suspected general 9 area of origin to understand the fire's movement and progression, as well as to identify the specific area 10 where it originated. In contrast, the number of fire movement indicators that fire agency investigators 11 documented and analyzed for the Mountain View Fire was quite small, which limited their ability to 12 draw reliable conclusions regarding the fire's specific origin area. It is also notable that one of the 13 investigators assisting the fire agency investigation identified ignition points that appear to be outside 14 the specific origin area identified by the fire agency report. 15

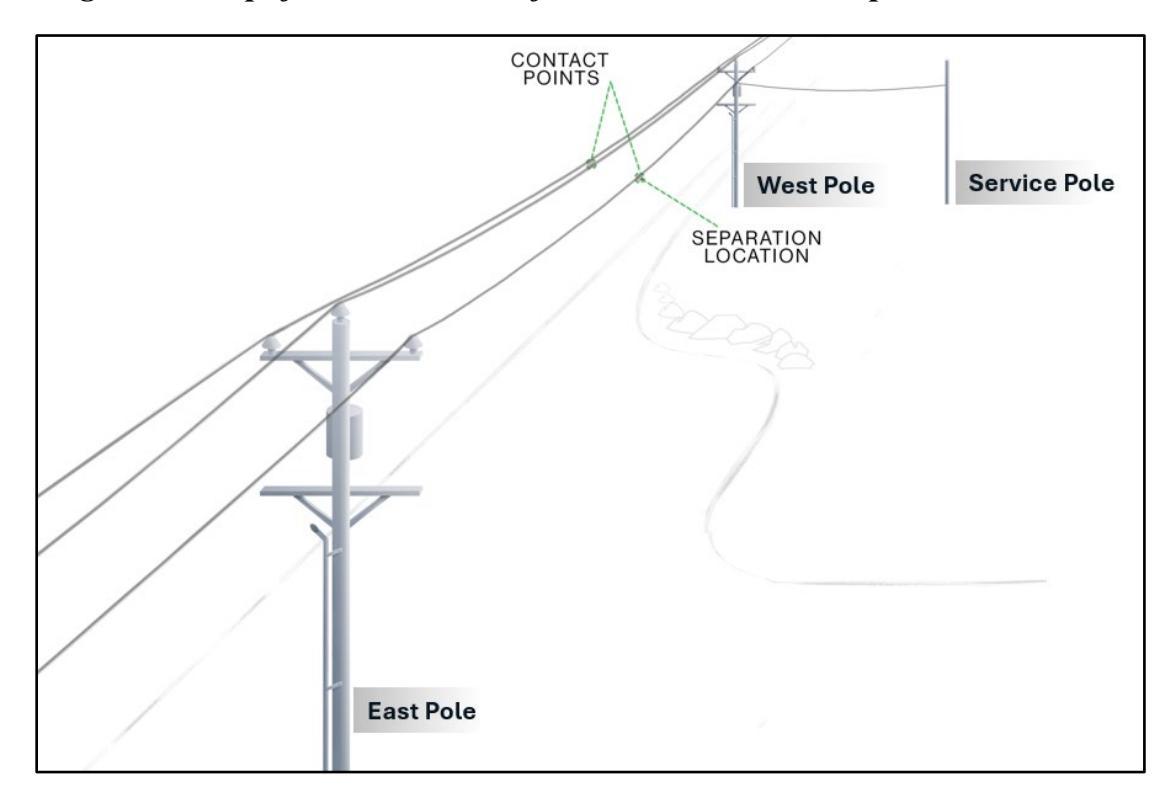
Figure 4: Simplified Illustration of Contact Points and Separation Location

The center and field phase conductors show evidence of recent arcing consistent with phase-to-phase contact on November 17, 2020. The area of contact was approximately mid-span between the West and East Poles, including at the location where the field phase conductor ultimately separated and fell to the ground.⁸ The field phase conductor exhibited arcing and melting on each end of the separation point. In particular, there was melting on every aluminum strand at all points of separation, including the steel core strand. The lack of oxidation and overall appearance of this evidence indicates that the damage is fresh and occurred shortly before the conductor was removed from the field. The center phase conductor also exhibited areas of arcing. The most pronounced area aligns with the location of the field phase conductor separation, indicating that the two conductors came into contact. Unlike the field phase conductor did not separate or fall to the ground, though some of the individual aluminum strands separated due to arcing and melting. The center and field phases did not exhibit evidence of old arcing.

The west end of the field phase conductor also exhibited discoloration, likely due to the ground fire. The evidence indicates the west side of the field phase conductor contacted another metal wire—likely the bare neutral wire associated with the triplex conductor between the West Pole and a service pole to its north and a guy wire supporting the West Pole. The east end of the field phase conductor exhibited mechanical damage. The conductor east of the separation point was de-energized due to the separation and apparently fell to the ground in a gravel parking area, where I understand it was driven over by multiple vehicles.

⁸ The conductor's point of separation was approximately 135 feet, 8 inches from the West Pole.

Although a metallurgist retained by plaintiffs in the civil litigation suggested the field phase conductor separated due to fatigue,⁹ that conclusion is not supported by the metallurgical evidence. In particular, fatigue results in striations and beachmarks that are clearly identifiable on the fracture surface.¹⁰ Yet no striations or beachmarks were present on the ends of the strands of the field phase conductor, and my review of the evidence showed no sign of separation due to fatigue. A fatigue separation also is unlikely in light of the strength of the materials comprising the ACSR and forces on the conductor between the East and West Poles. The strength of the ACSR conductor far exceeded the applied forces, and the strength of the steel core alone is more than sufficient to support the conductor for a span between the West and East Poles, even during windy conditions such as on November 17, 2020.
