**Advice Letter No. 152-E
(U 933-E)**

Subject: Meyers 3400 Distribution Line PU Code § 320 Deviation

Proposed Alternative Pole Replacements

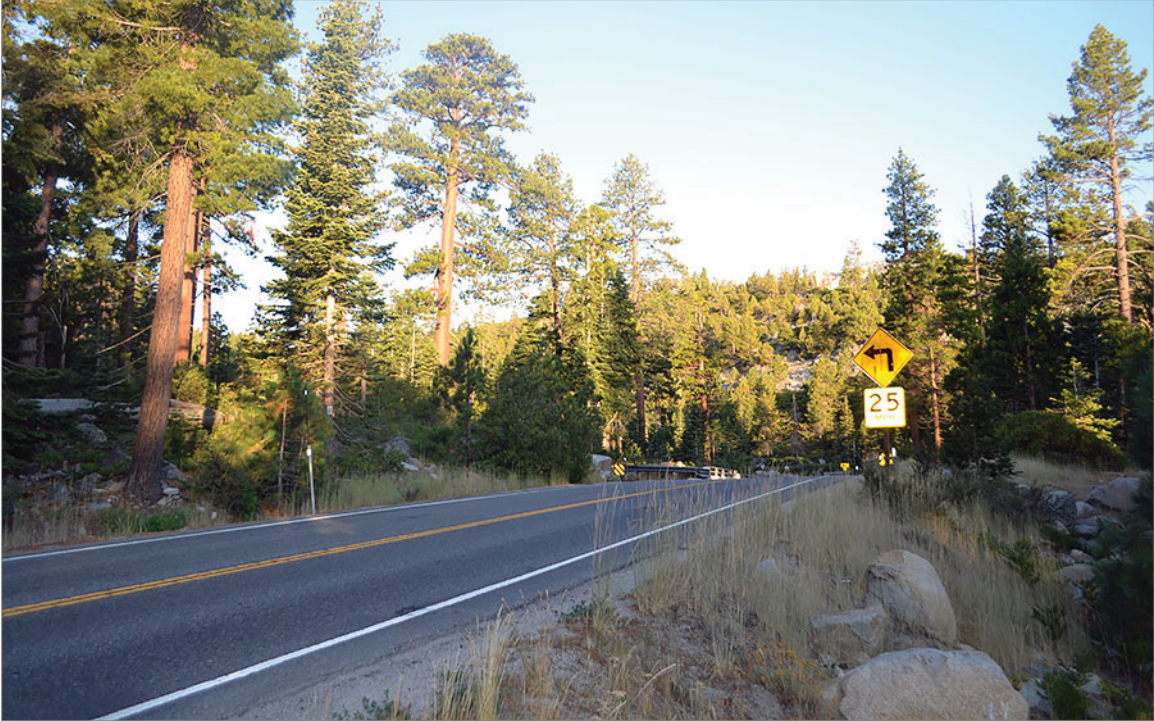
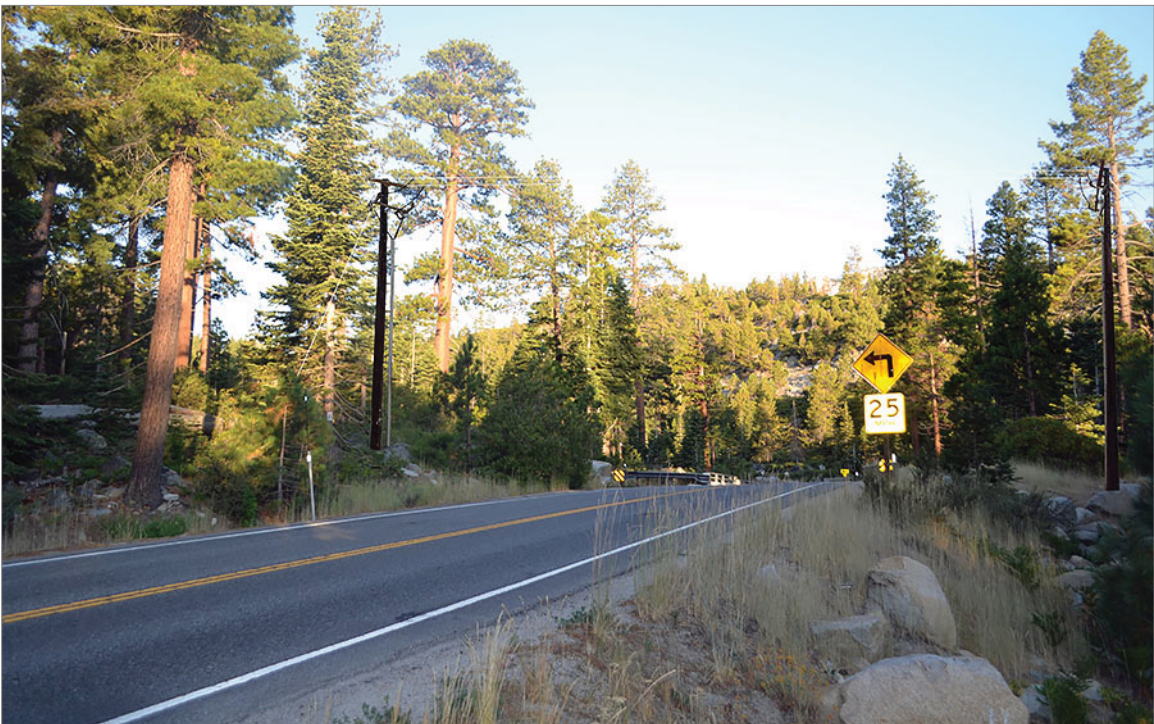
Figure 3 Viewpoint 1: Northbound View at Cascade Creek Bridge

Existing view of project site at Cascade Creek Bridge for northbound travelers on Highway 89.

Simulated view showing installed poles and line.

The visual quality of the existing corridor will not be altered by the proposed project. The project would eliminate three existing crossings of SR 89, with approximately 2,545 feet of visible overhead wire and associated poles. Approximately eight of the existing poles are visible from SR 89. The project would construct five new poles and associated electric lines, creating one new aerial crossing of SR 89 with approximately 120 feet of visible overhead wire. The reduction in the number of poles and length of utility wire visible within the corridor would increase intactness and unity within the scenic corridor.

Resource Change (changes to visual resources as measured by changes in visual character and visual quality) will be low. The proposed project would reduce the number of aerial crossings and poles visible from SR 89; therefore, the visual quality would increase, and the resource change would be positive.

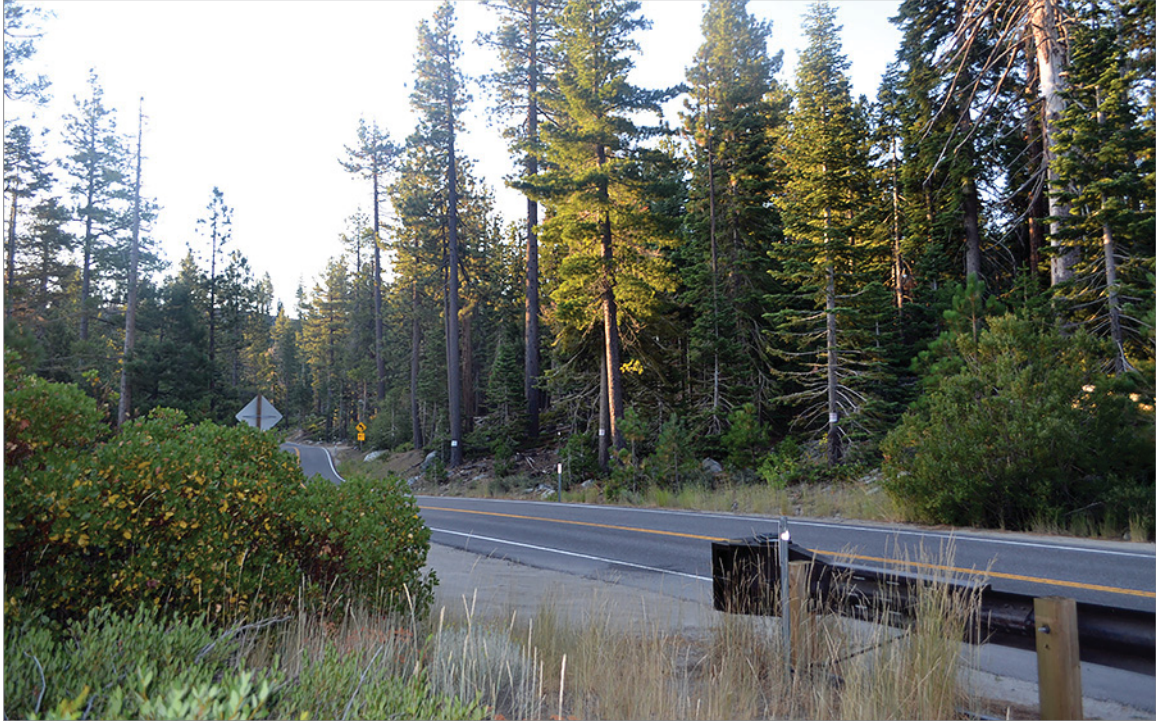
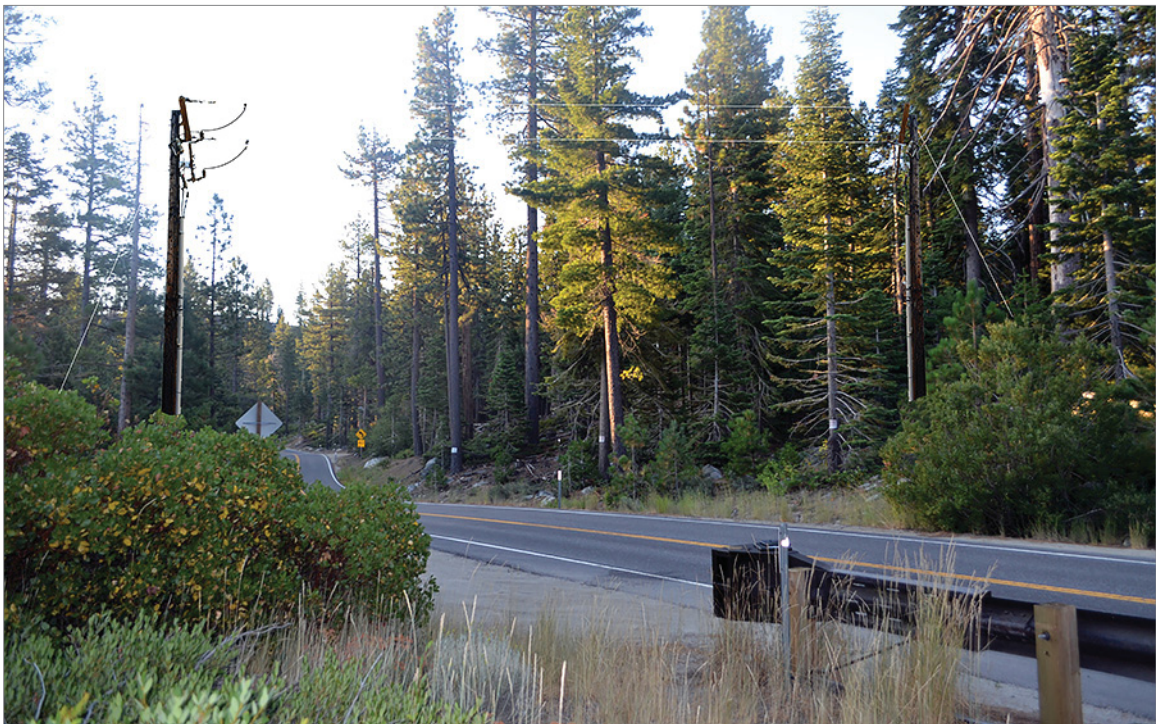
Figure 4 Viewpoint 2: Southeast View at Cascade Creek Bridge

Existing view of project site at Cascade Creek Bridge for travelers looking southeast on Highway 89.

Simulated view showing installed poles and line.

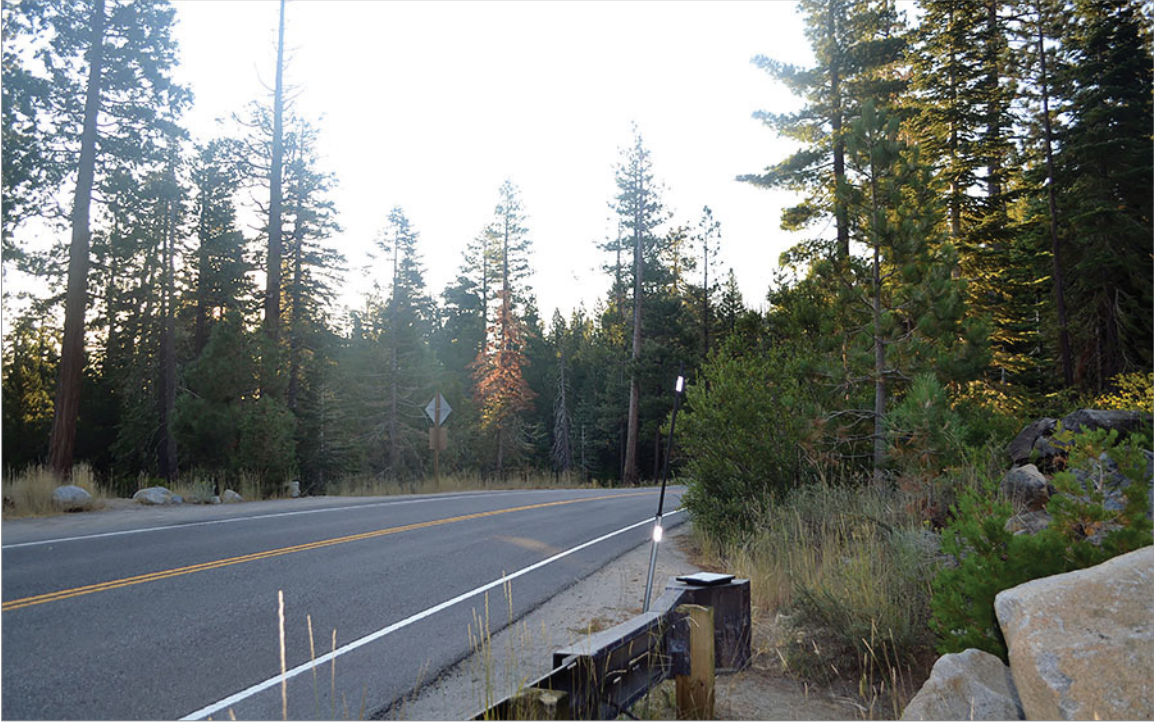
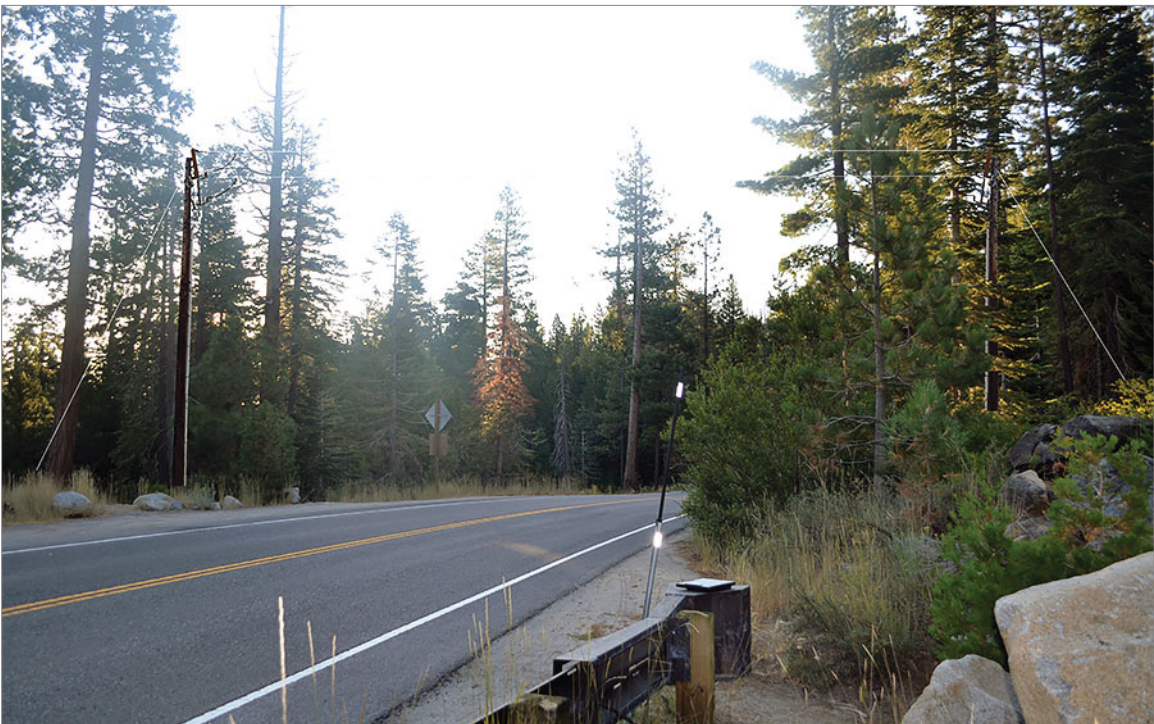
Figure 5 Viewpoint 3: Southbound View at Cascade Creek Bridge

Existing view of project site at Cascade Creek Bridge for southbound travelers on Highway 89.

Simulated view showing installed poles and line.

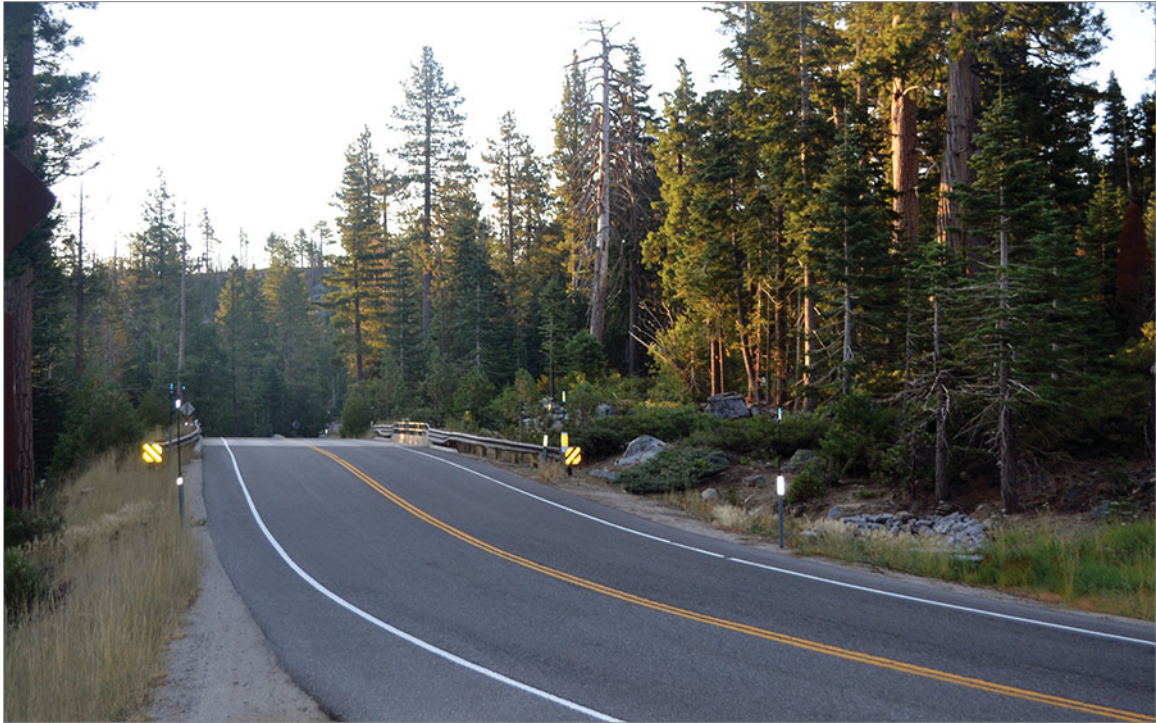
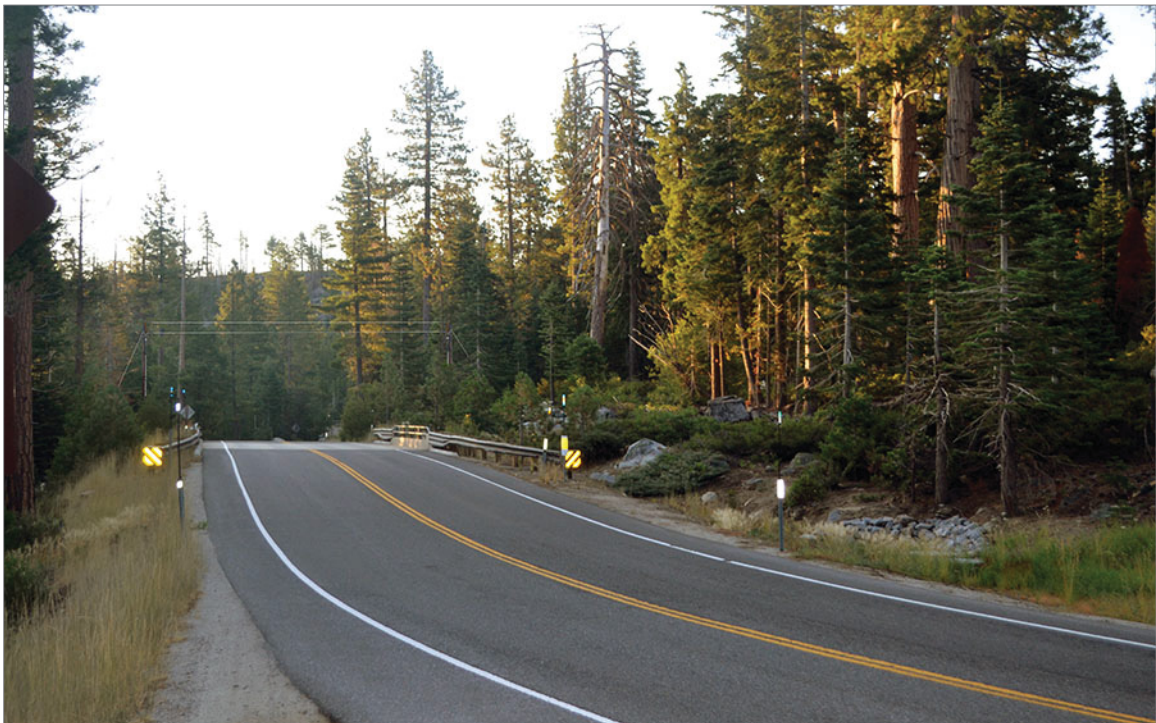
Figure 6 Viewpoint 4: View for Southbound Travelers Toward Cascade Creek

Existing view toward project site at Cascade Creek Bridge for southbound travelers from curve on Highway 89 (approximately 100 feet from proposed pole and line location).

Simulated view for southbound travelers showing installed poles and lines.

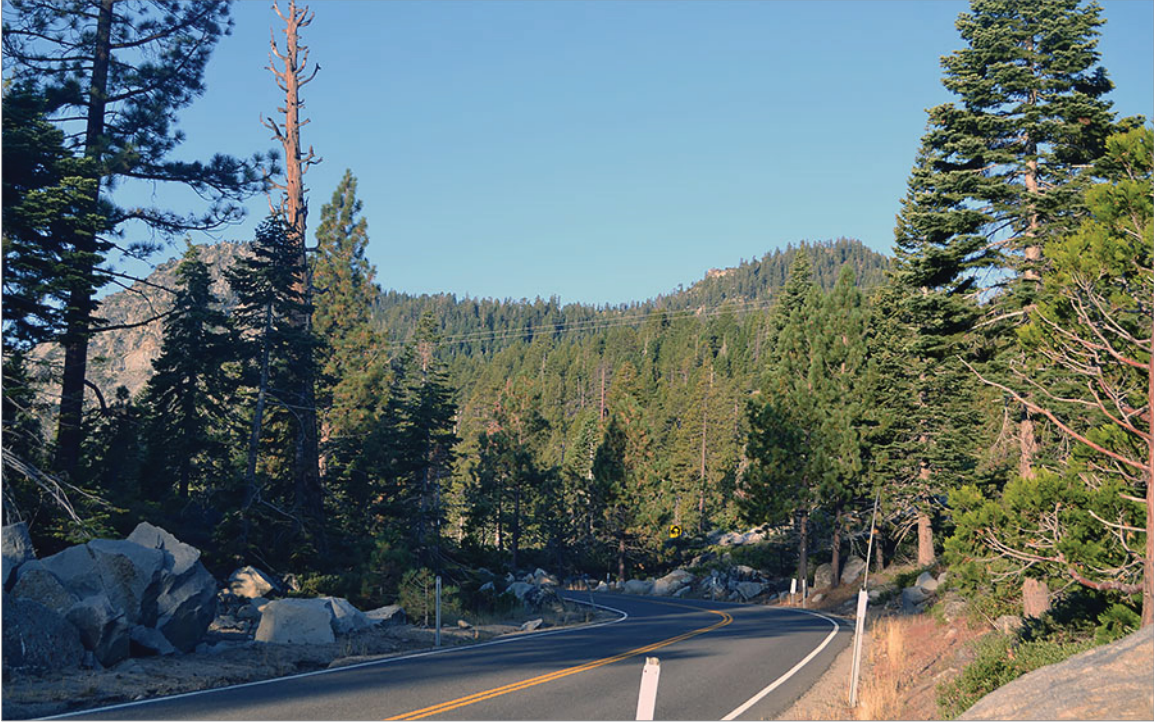
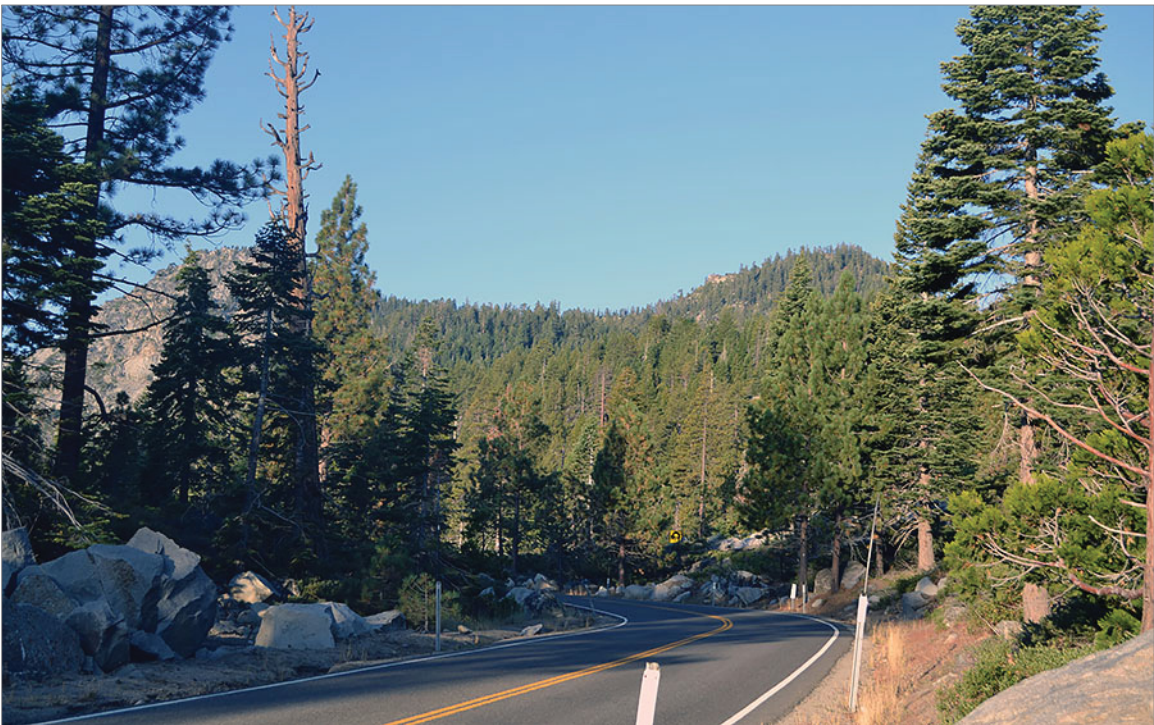
Figure 7 Viewpoint 5: View for Northbound Travelers Near Switchback

Existing view looking west near switchback for northbound travelers. Existing view showing existing poles and electrical lines crossing the roadway.

Simulated view showing poles and lines removed.

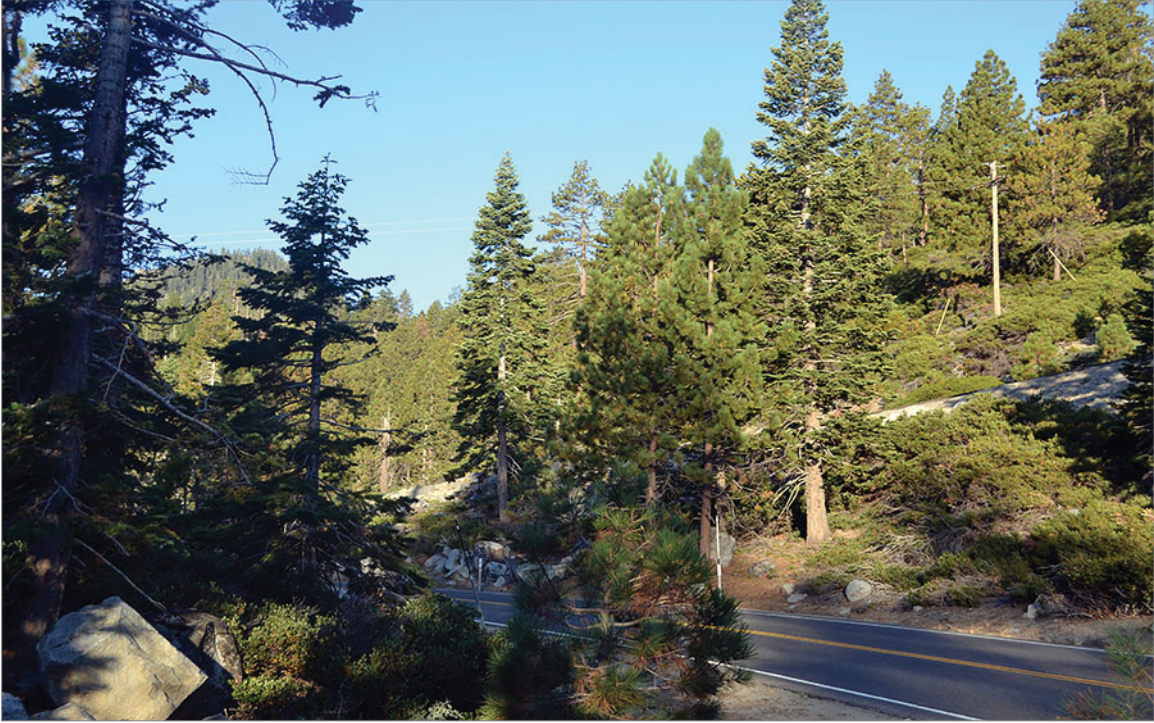
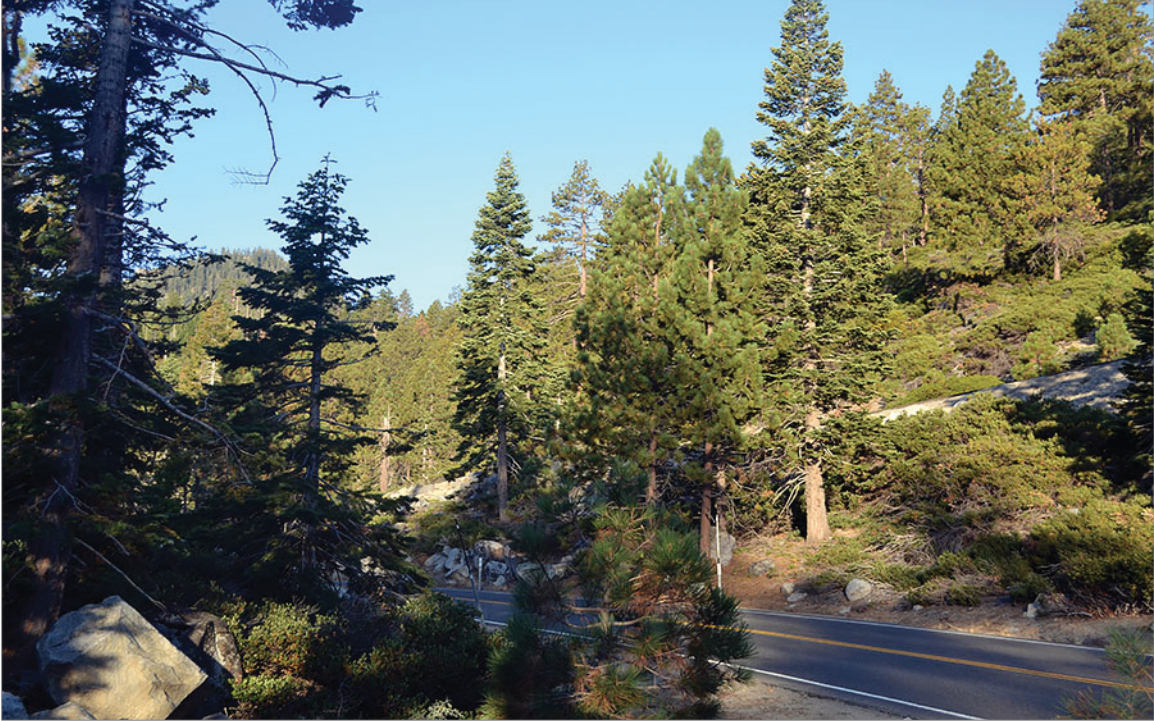
Figure 8 Viewpoint 6: View Upslope from Highway 89 in Close Proximity to Switchback

Existing view showing existing poles and electrical lines crossing the roadway.

Simulated view showing poles and lines removed.

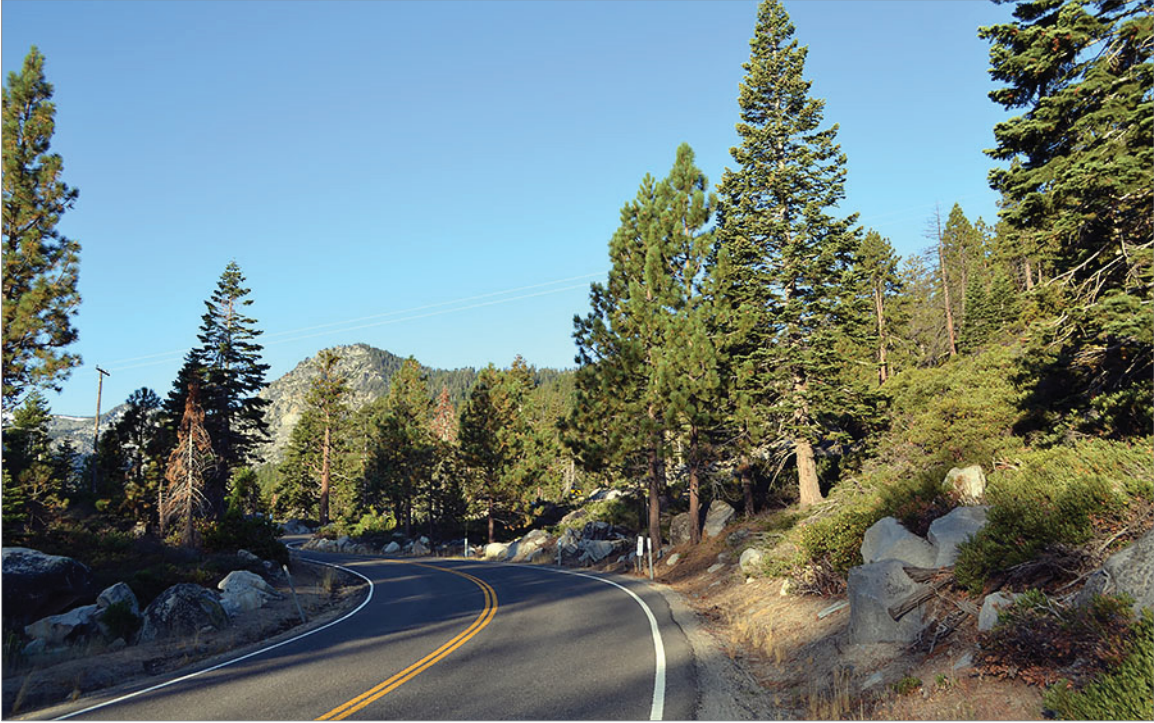
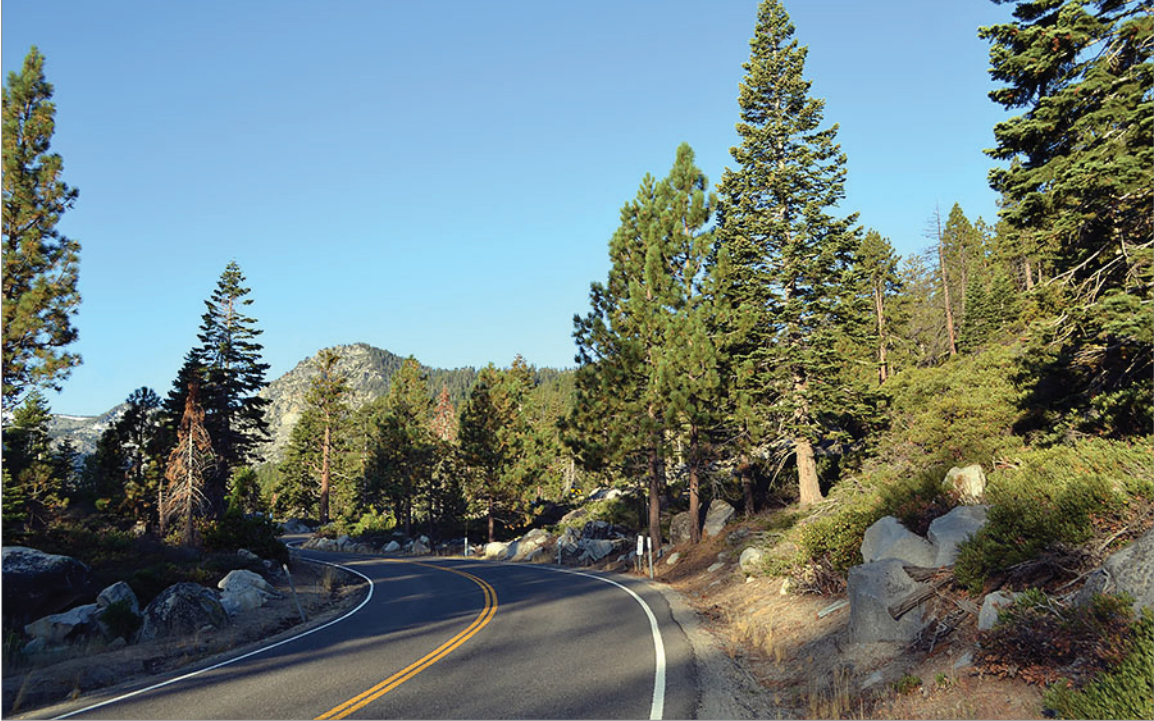
Existing view along northbound Highway 89 close to the switchback. Existing view showing existing poles and electrical lines crossing the roadway.

Simulated view showing poles and lines removed.
