Mountain View Fire Cost Recovery Application

Before the California Public Utilities Commission

Liberty-03: Prudence of Operations

Tahoe Vista, California

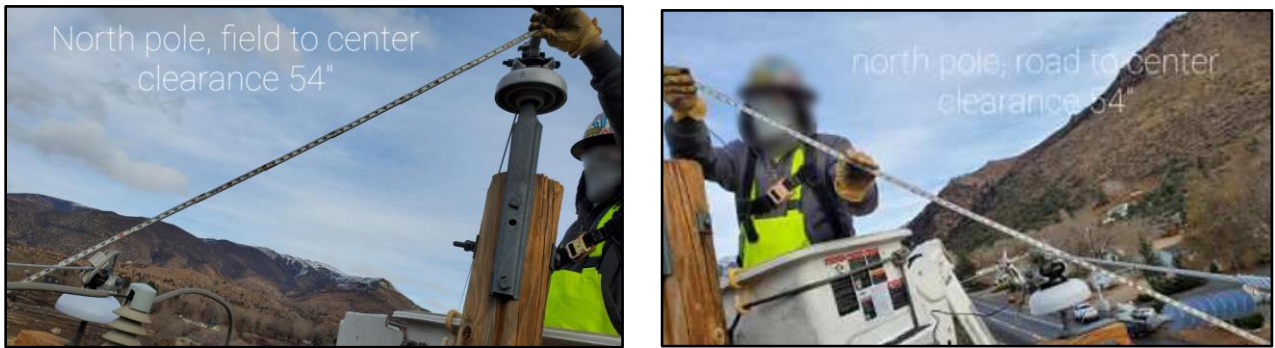
Figures 6 (Left) and 7 (Right): Post-Fire Conductor Radial Clearance Measurements at West Pole¹⁷

¹⁷ Distance of 54 inches between the center and road phase conductors (left photograph) and between center and field phase conductors (right photograph).

¹⁶ See GO 95, Rule 54.4(C)(1)(c) ("When crossarms are used to support conductors of the same circuit at different levels (as in triangular or vertical configuration), the crossarms may be arranged so that the vertical separation of the conductors of the same circuit shall not be less than the pin spacings of Table 2, Case 15."); *id.*, Rule 38, Table 2, Case 15.

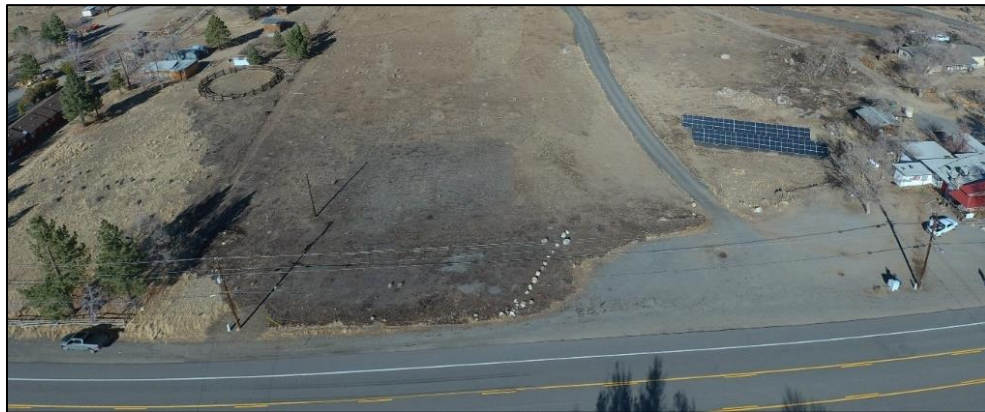
Figure 14: Photograph of Specific Facilities from November 24, 2020

Prior to the Mountain View Fire, the West Pole was last cleared on September 23, 2020. Figure 13 shows the before and after images of the West Pole, as documented by the contractor who completed the pole clearing work. There was no vegetation growth within a ten-foot radius of the East Pole. As shown in Figure 14, an aerial photograph taken one week after the fire show vegetation clearances around the poles, and the fire agency report affirmed the Specific Facilities were maintained in compliance with PRC 4292.⁴⁰

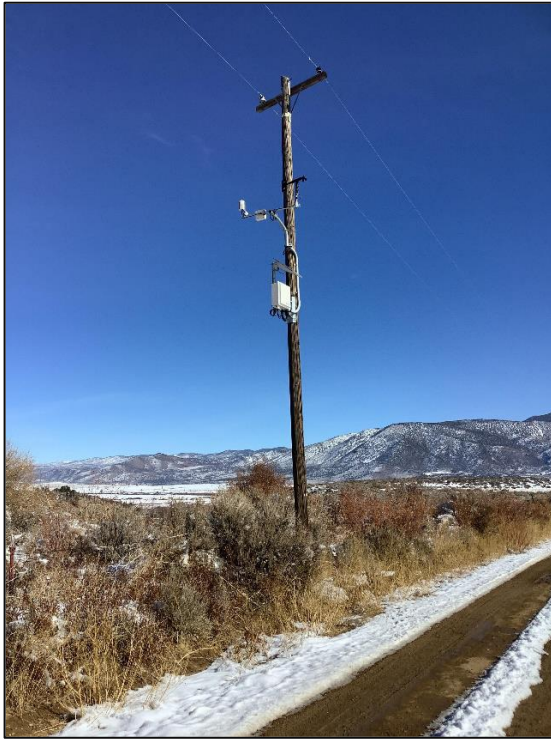
LIB-06 Weather Station

Figure 18: November 10, 2020 Photographs Showing Two Weather Stations on the Topaz 1261 Circuit^{s2}
